TOYOTA ROAD IMPROVEMENT PROJECT (TRIP)

NATIONAL HIGHWAY - 5

For Toyota Road Improvement Project, approximately 13.5 km segment of the N-5 highway is considered. It starts from the Kalaboard bus stop and ends at Port Qasim Chowrangi. The part of highway considered for the study is of utmost importance due to the presence of industries and significant landmarks. The commercial and industrial land use on the N-5 shows that a diversified proportion of vehicle mix can be observed in this segment consisting of motorcycles, cars, pick-up vans and a significant proportion of heavy vehicles.

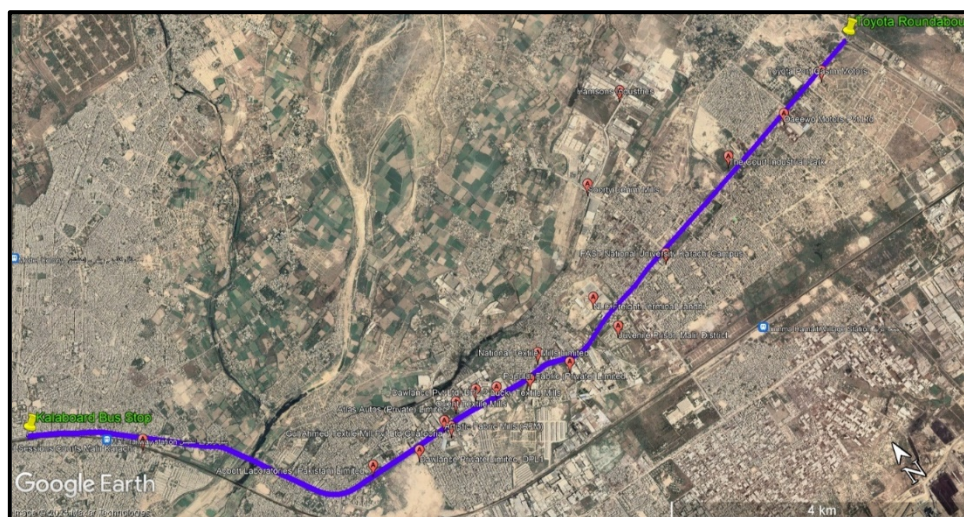
Figure 1 Selected Road Section Karachi from Nehal Hospital to Port Qasim Chowrangi

The starting section of approximately 13.5 km of this highway considered for this study is present in Karachi as shown in Figure 1. It starts from the Kalaboard bus stop and ends at Port Qasim Chowrangi.

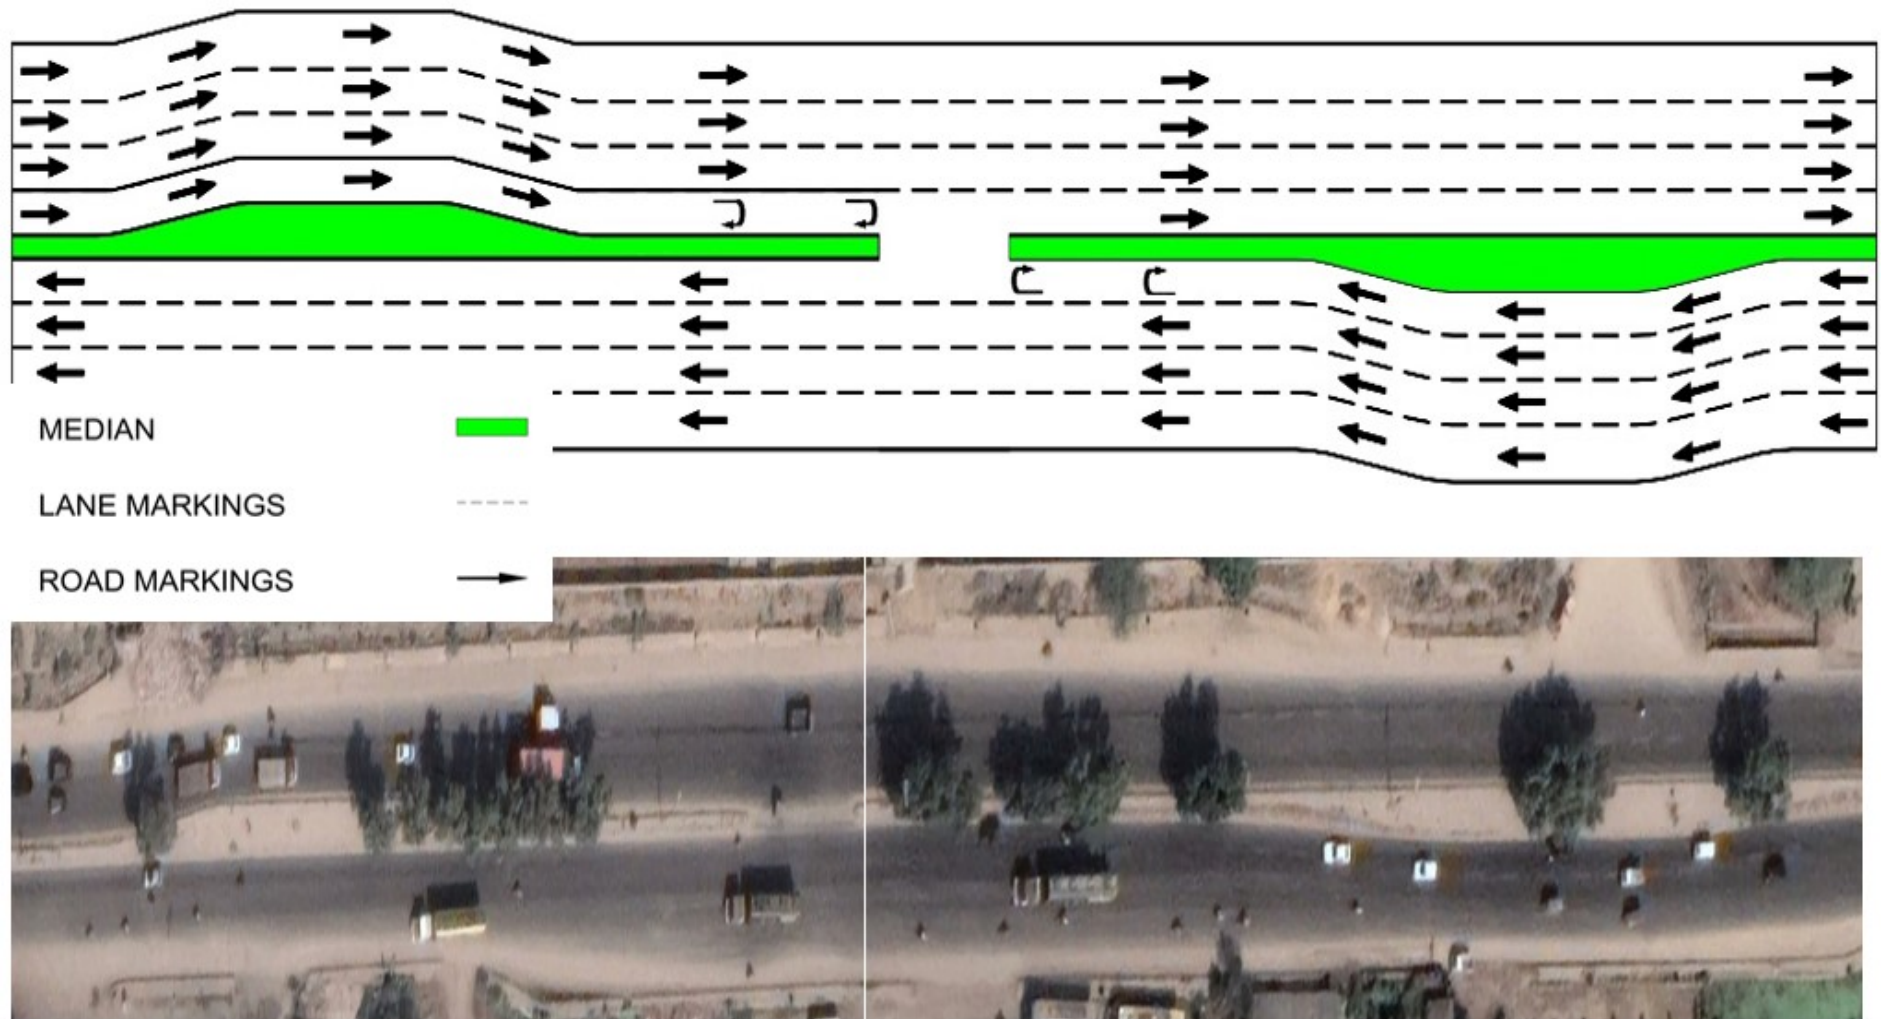
Figure 2 Road Section near Razaqabad U-turn

Medians are provided to divide the carriageways to separate the traffic flow in each direction. The road of N5 has many defects. First, a lot of segments on the road are not provided with a median instead new jersey barriers are used for separating the traffic. Second, the segments where medians are provided have not been properly designed. As shown in Figure 2, there is a sudden increase in the width of the median near 'Razaqabad'. One issue that may arise is confusion or uncertainty among drivers about which lane to stay in. The uneven or inconsistent pattern lead to unexpected lane changes, sudden braking, and other unsafe driving behaviours that increase the risk of accidents and traffic congestion in particular segments.

Short Term: Implement signage indicating the presence of an abrupt curve along with proper lighting, and trim trees to ensure improved visibility and safety for drivers.

Medium Term: Installation of road safety studs on flushed median.

Long Term: Implementing proper chamfering of the median will help enhance safety and facilitate smoother traffic flow along the road.

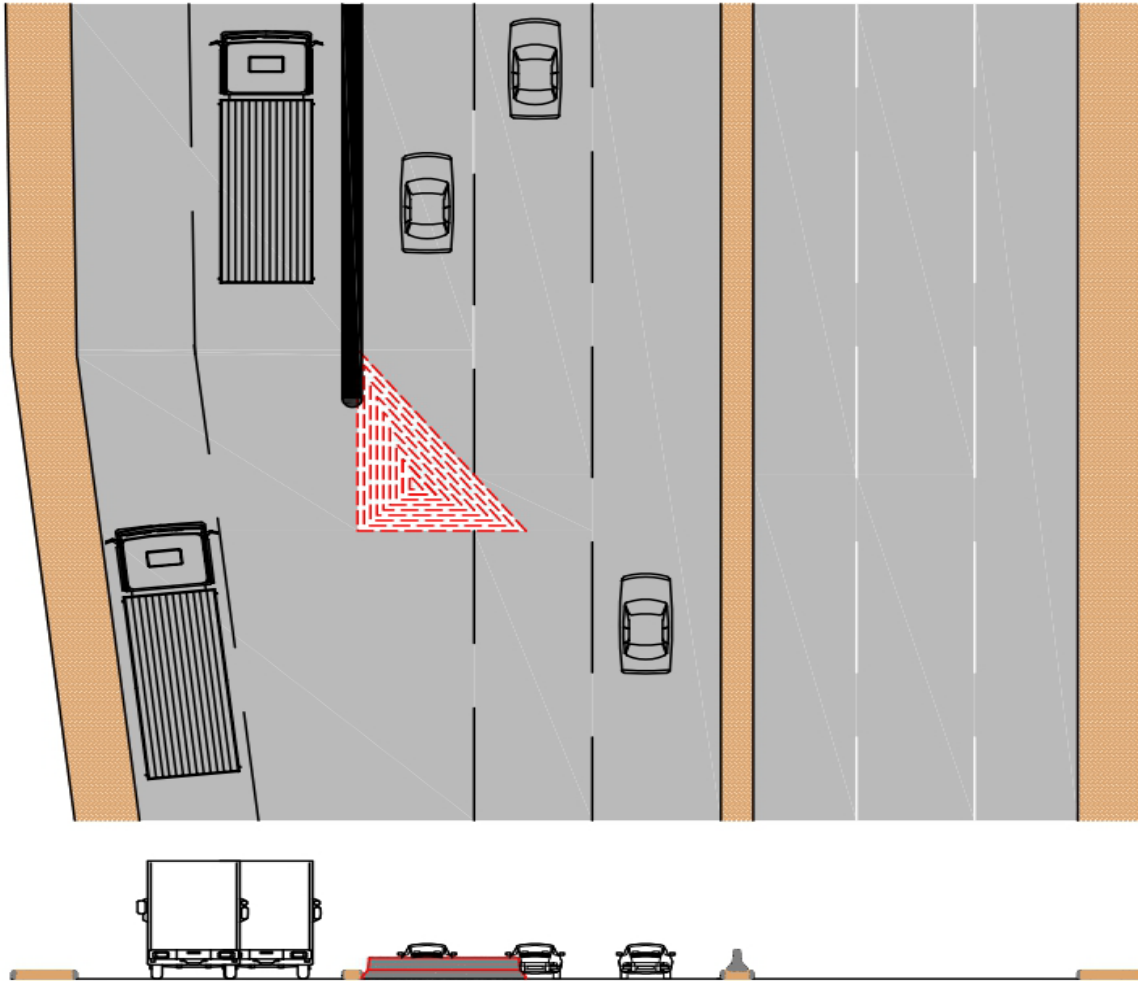
Figure 7 Manzil pump flyover

The traffic police at the Manzil Pump flyover have placed a barrier at the beginning of the flyover during daytime as shown in Figure 6. The intention behind this blocking is to prevent heavy traffic from entering. However, this barrier also causes congestion as vehicles to have to slow down and wait for their turn to pass through the barrier.

Short term: To install traffic surveillance cameras functioning based on ITS.

Medium term: The medium-term solution of the issue is to place a Movable Vehicle Height restriction pole in order to prevent heavy traffic from entering during day time.

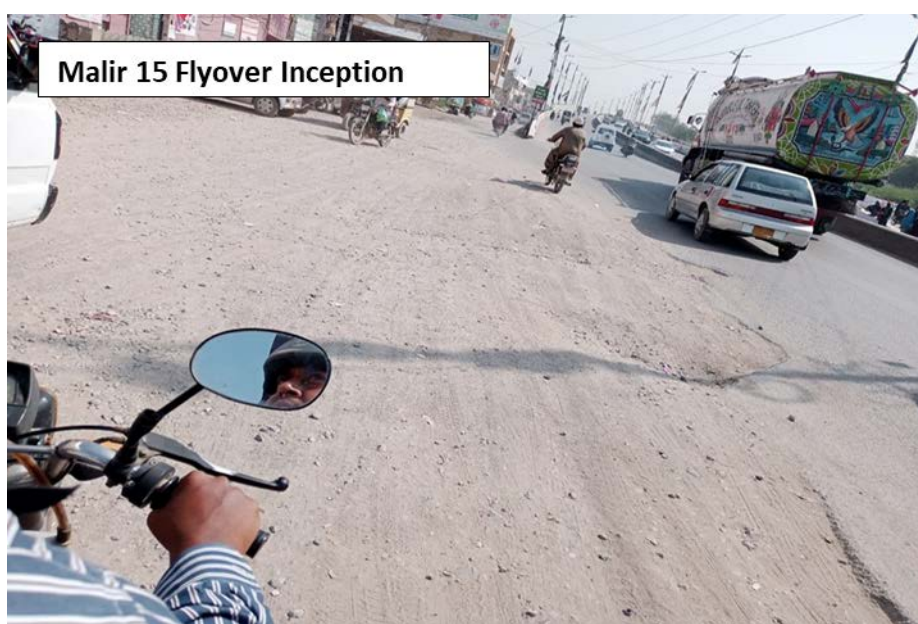
Defects Identified: Damaged Pavement

Long term: The long-term solution for potholes is to perform surfacing or overlay of the road surface.

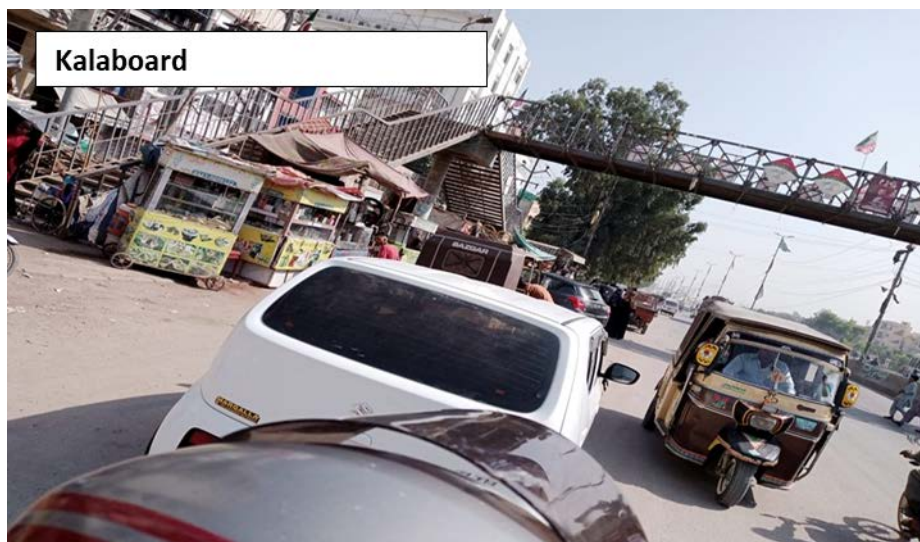
Defects Identified: Encroachment

Short term: Immediate removal of encroachments through enforcement actions, such as Police challan or eviction notices, to clear the affected areas.

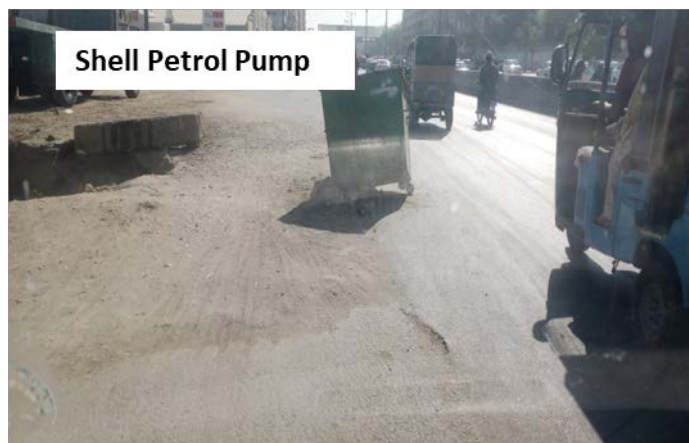
Defects Identified: Pothole/Ditches

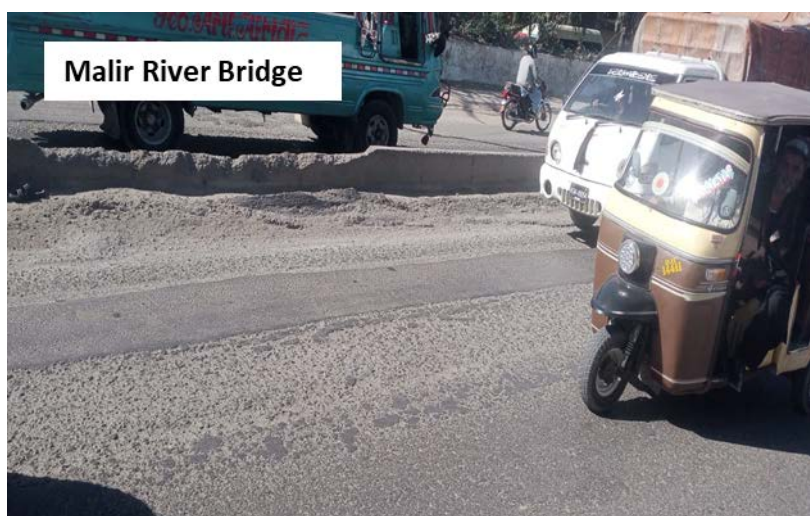
Defects Identified: Inadequate Height of NJ barriers

Medium term: The medium-term solution for inadequate height New Jersey barriers is to install metal sheets on the barrier to separate both directional traffic

Long term: The long-term solution for inadequate height New Jersey barriers is to install barriers that are at least 3.5 feet high.

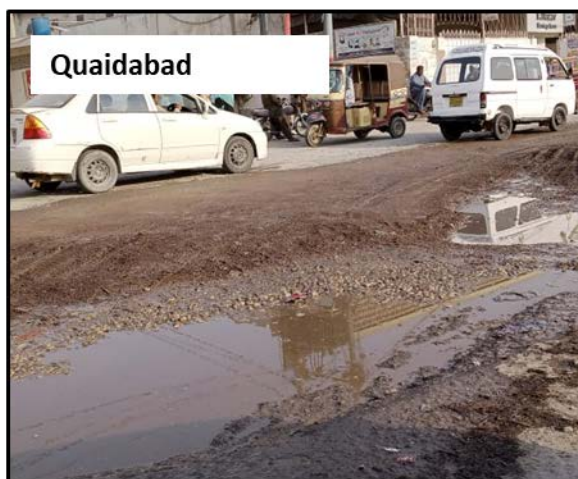
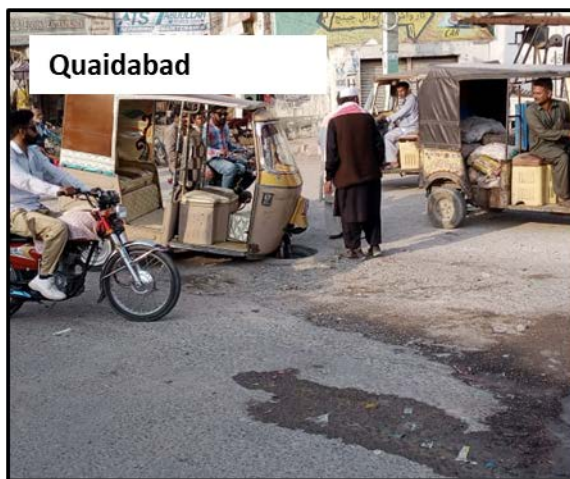
Defects Identified: Pothole/ Ditches

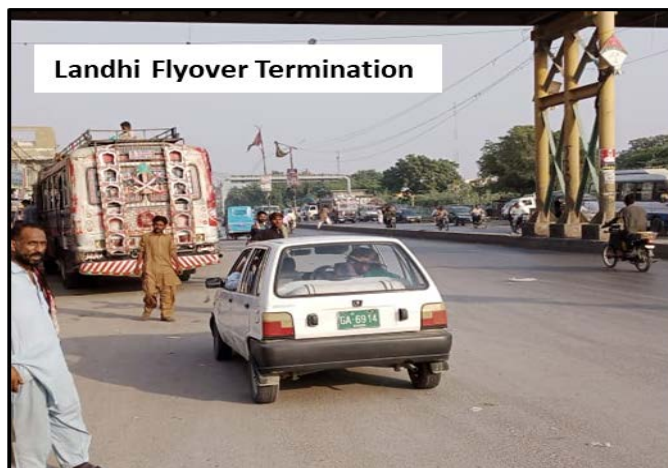
Defects Identified: Illegal Parking

Short term: Police challan.

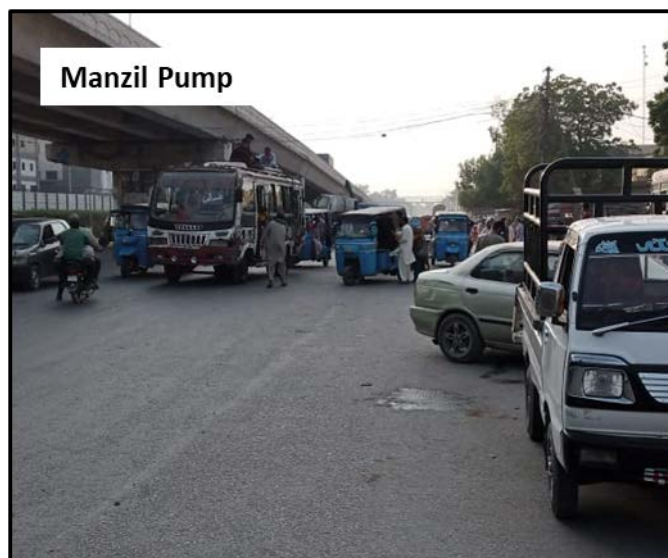
Defects Identified: Illegal Parking/

Short term: Police challan.

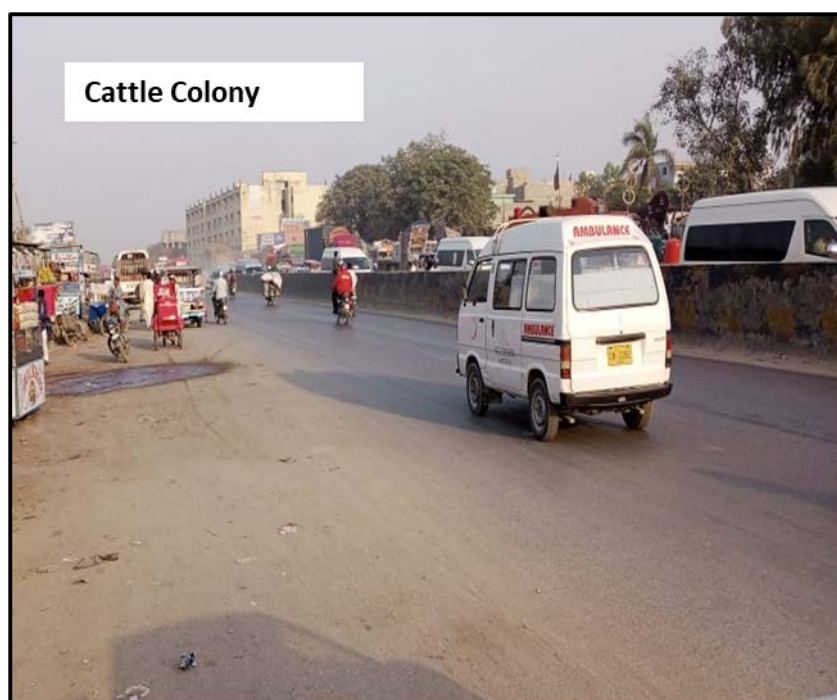
Defects Identified: Encroachment

Short term: Immediate removal of encroachments through enforcement actions, such as Police challan or eviction notices, to clear the affected areas.

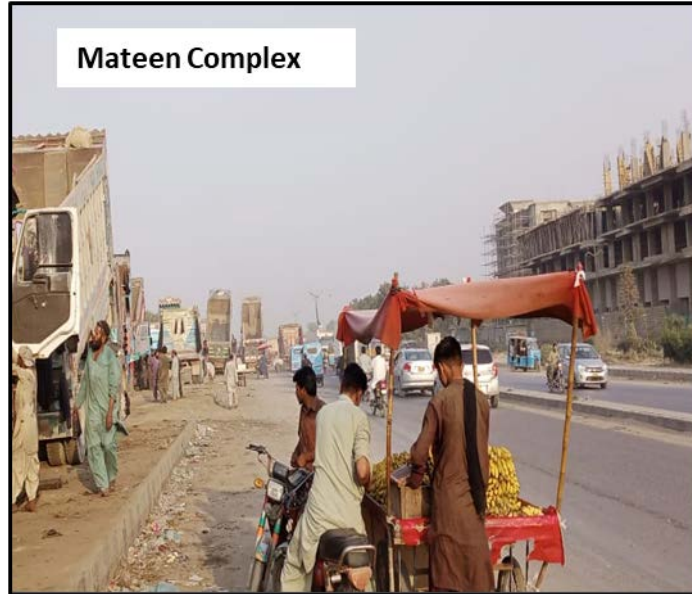
Defects Identified: Encroachment

Short term: Immediate removal of encroachments through enforcement actions, such as Police challan or eviction notices, to clear the affected areas.

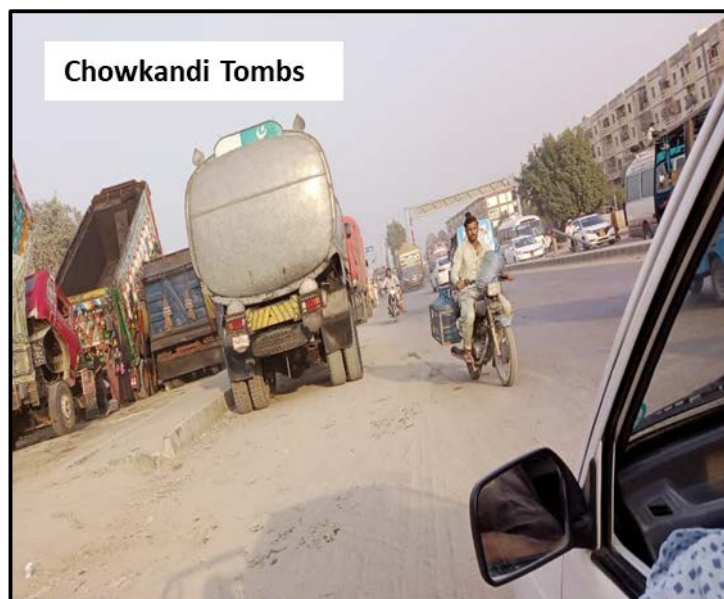
Defects Identified: Wrongway Movement

Short term: Strong Enforcement.

Long term: The long-term solution for wrong-way movement is the construction of service roads along NH5.

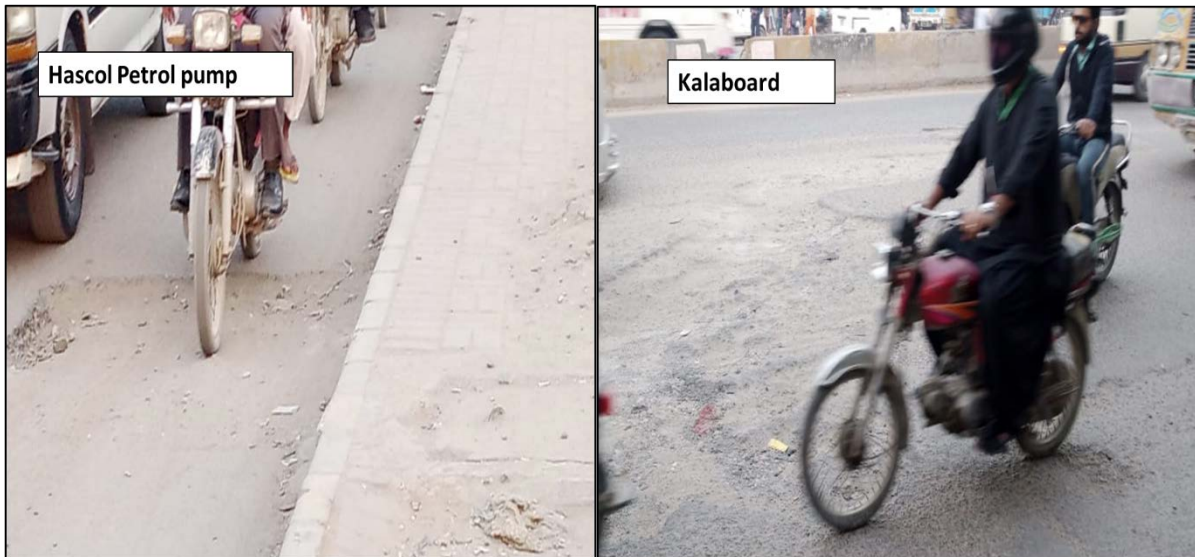
Defects Identified: Pothole/Ditch

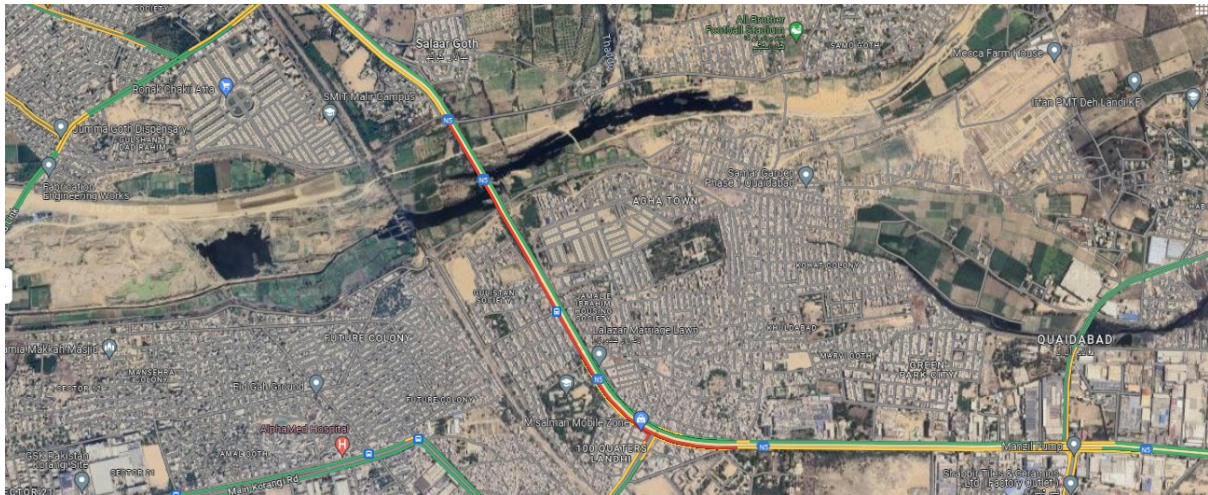
Figure 14 Congested Road Segment

The bottleneck and congested segment on the national highway refer to a specific area where the flow of traffic is restricted or slowed down significantly, leading to congestion and delays. In such areas, vehicles may be forced to slow down or come to a complete

stop, leading to a buildup of vehicles and delays in travel time. The bottleneck and congestion can cause frustration among drivers and may also increase the risk of accidents. Efforts to alleviate such congestion often involve infrastructure improvements, traffic management strategies, and enforcement of traffic regulations. Following is the most congested segment found on National Highway starting from inception of Malir River bridge to termination of Landhi flyover.
