TOYOTA ROAD IMPROVEMENT PROJECT (TRIP)

Rashid Minhas Road

Chapter 3: Road Safety Audit

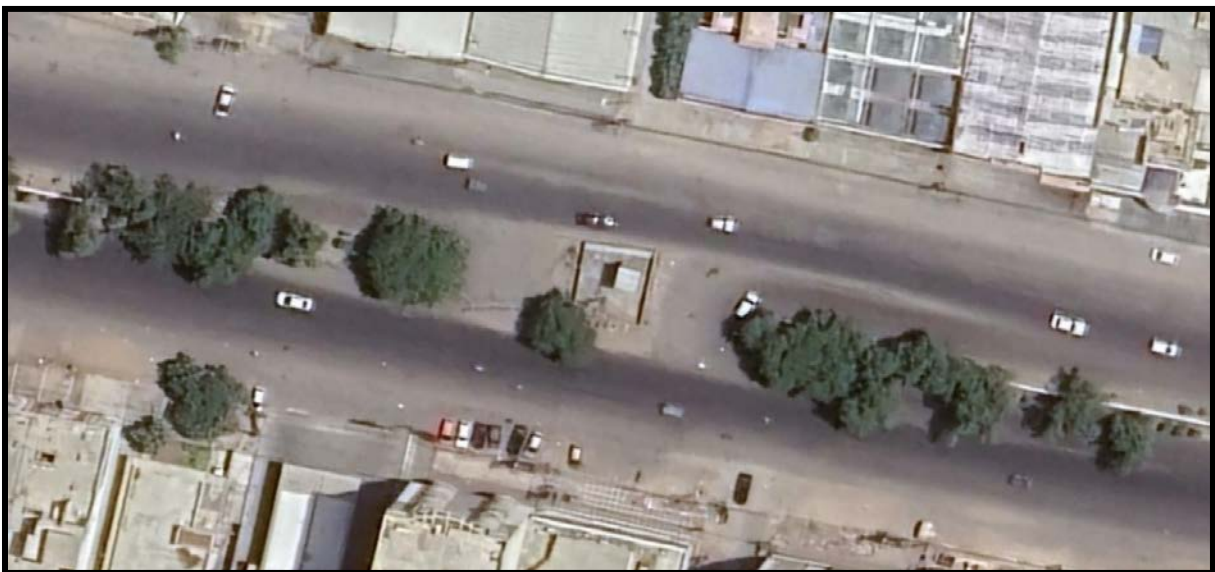
Figure 2 Existing U-turn at moti mehal

The existing U-turn near Moti Mehal creates congestion as Intiaz Parkings reduce the width of the existing road. Additionally, rickshaw drivers from opposite road enter this U-turn in the wrong direction and merge into the through traffic.

Short Term: Not applicable.

Medium Term: Provide road safety studs to separate through traffic and turning traffic

Long Term: Intiaz Parking should be properly managed to ensure no parking on the main arterial / Relocate the U-turn.

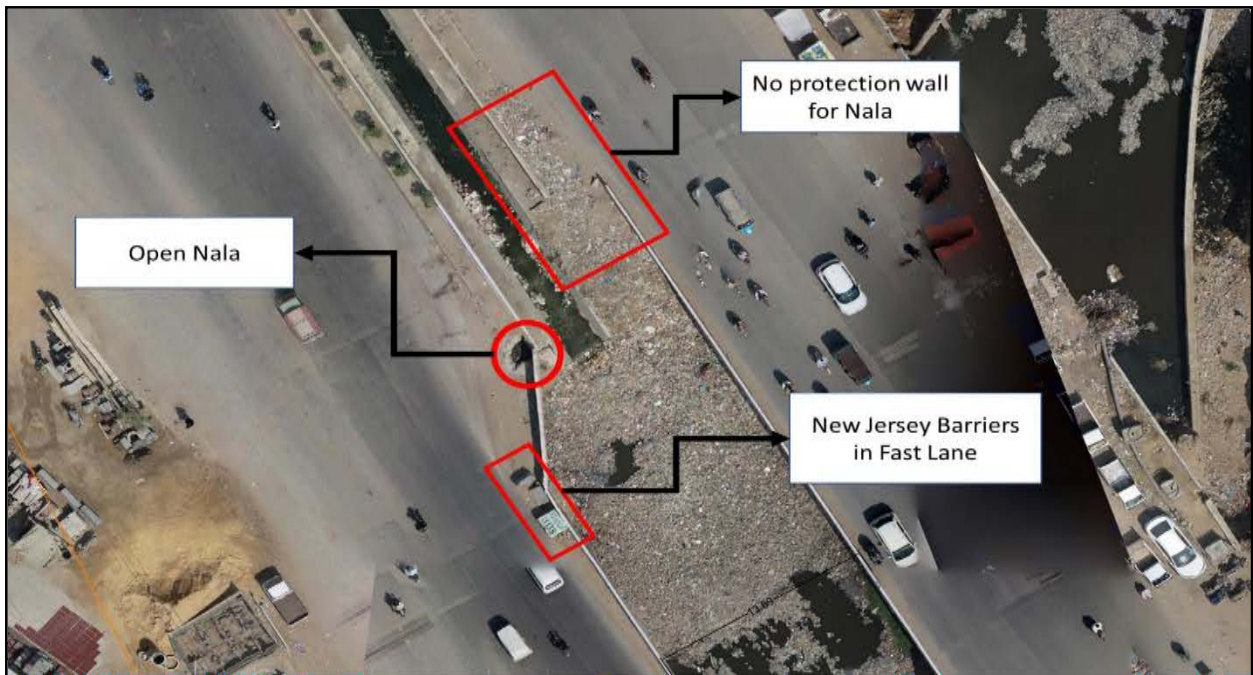
Open Nala has been observed near Dayar-e-Shereen gujjar nala. The serious hazard in fast lane track of that location is that there is no protection wall present which can cause accident. Furthermore, some parts of footpath on the service road present from Nagan to Gujjar Nala are not properly covered and no street lightning is provided therefore it causing potential of accident.

Medium term: The medium-term solution for broken wall of Nala is to pace NJ barriers to cover the opening.

Long term: The long-term solution is to construct a protective wall.

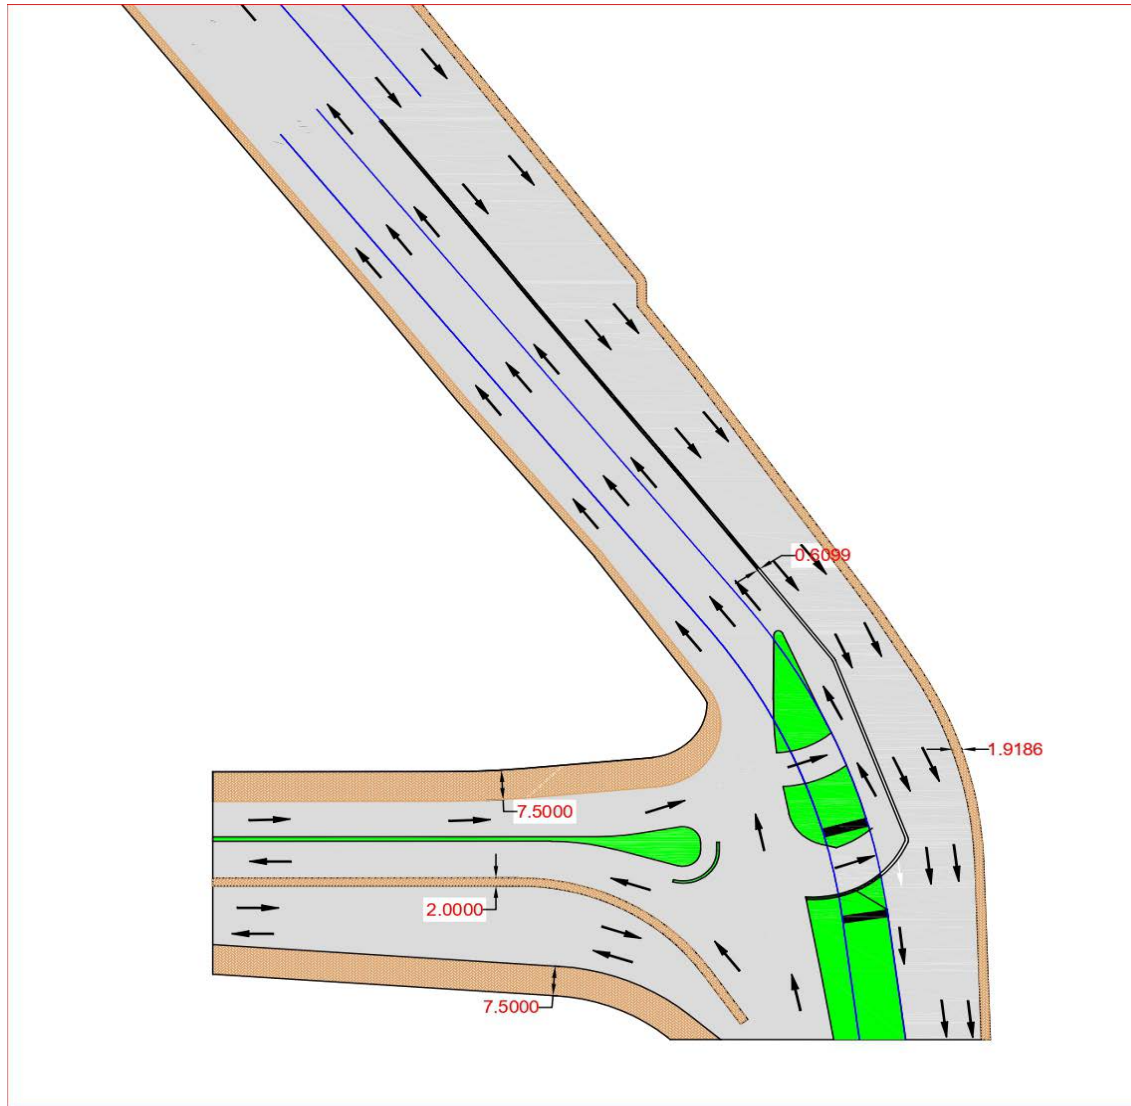
Figure

An intersection, referred to as a crossroad, is a location where two or more roads meet or intersect. Rashid Minhas has five primary and six minor intersections. These intersections are one of the factors that add to traffic congestion. The T - intersection present at millennium mall connects the Stadium road with Rashid Minhas Road serving a significant amount of traffic volume. There are various redundant movements present without presence of any signage, signal, or traffic facility, therefore increasing the conflicting points for the intersection as shown in **Error! Reference source not found..** These turning movements require additional time and space, which can cause congestion and delays, particularly during peak traffic times. Furthermore, it allows unsafe pedestrian movements, wrong way movements, and increases potential risk of collisions on the road.

Short term: Removal of parking by Rickshaw/Chingchi and encroachment.

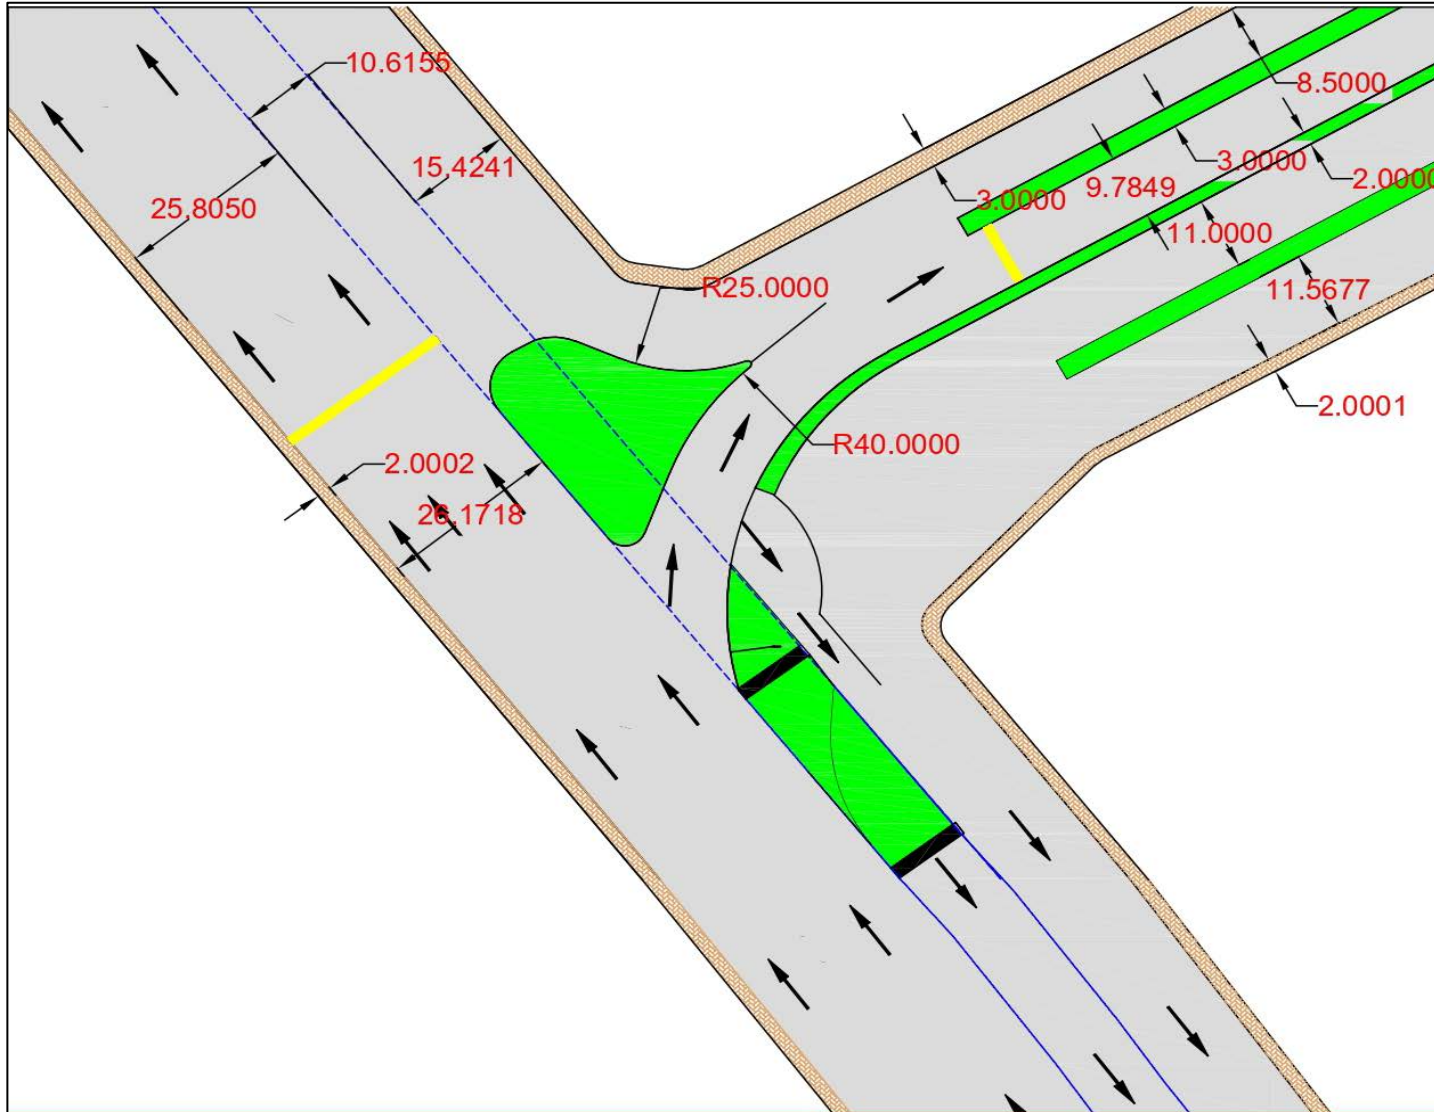
Figure 6 Johar Morr

The Johar intersection at Rashid Minhas is a critical spot concerning pedestrian safety. Most vehicles passing through the Johar intersection are traveling at high speeds. Nearby, there are numerous shops where pedestrians frequent, as well as many residential buildings where people live and travel daily. Vehicles utilizing the intersection and those bypassing it tend to maintain high speeds, posing a significant risk to pedestrian safety.

Short term: Traffic calming devices and provision of a constable during peak hours to help pedestrians cross the road.

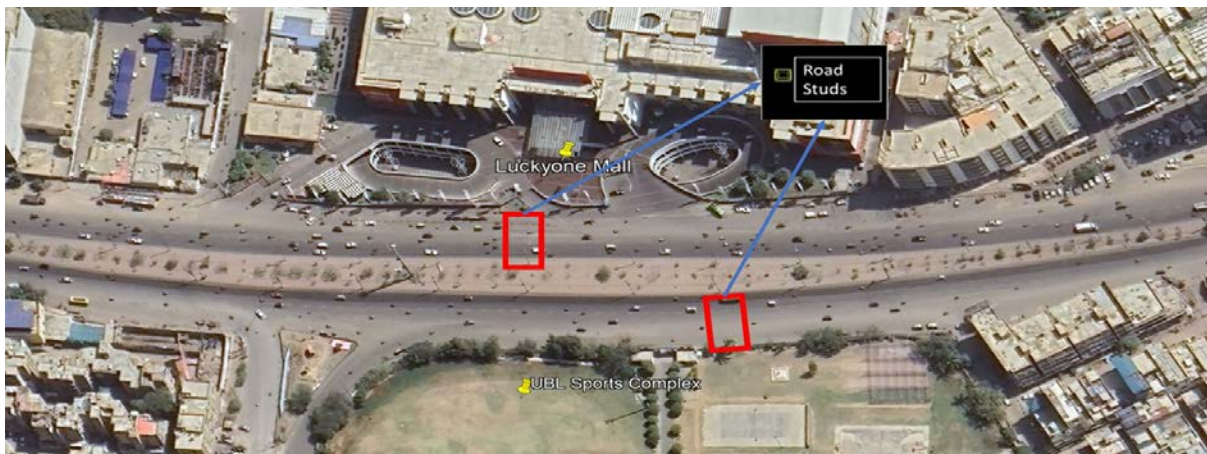
Figure 7 Lucky one Mall Proposed

The pedestrian issues at Lucky One Mall present a significant risk to road users due to several factors. Firstly, the mall's location likely attracts a high volume of pedestrian traffic, leading to congestion and potential conflicts between pedestrians and vehicles on surrounding roads. Secondly, inadequate pedestrian infrastructure such as crosswalks, sidewalks, and pedestrian signals can further exacerbate safety concerns, increasing the likelihood of accidents and injuries. Additionally, if pedestrians are not provided with safe and designated crossing points, they may resort to crossing the road at unsafe locations, putting themselves and drivers at risk. Addressing these pedestrian issues is crucial to ensuring the safety and smooth flow of traffic in the vicinity of Lucky One Mall. This may involve implementing improved pedestrian facilities, enhancing traffic management measures, and raising awareness among both pedestrians and motorists about the importance of road safety.

Short term: Traffic calming devices and provision of a constable during peak hours to help pedestrians cross the road.

Long term: Pedestrian Bridge

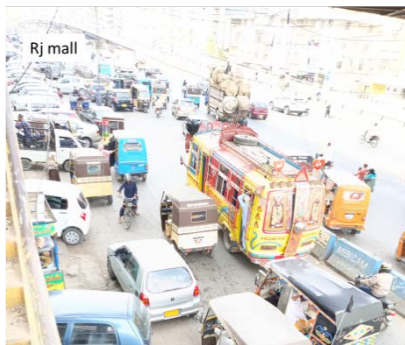
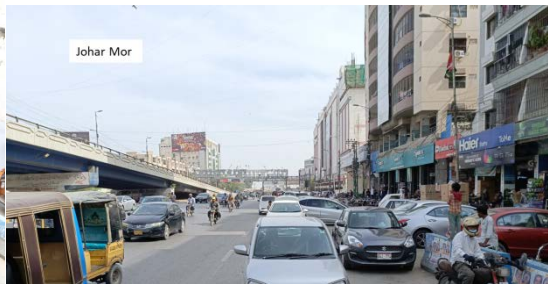
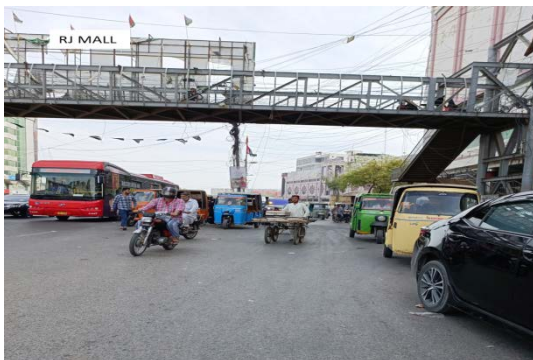
Defects Identified: On road Parking

Short term: Police challan.

Long term: Providing proper parking for vehicle.

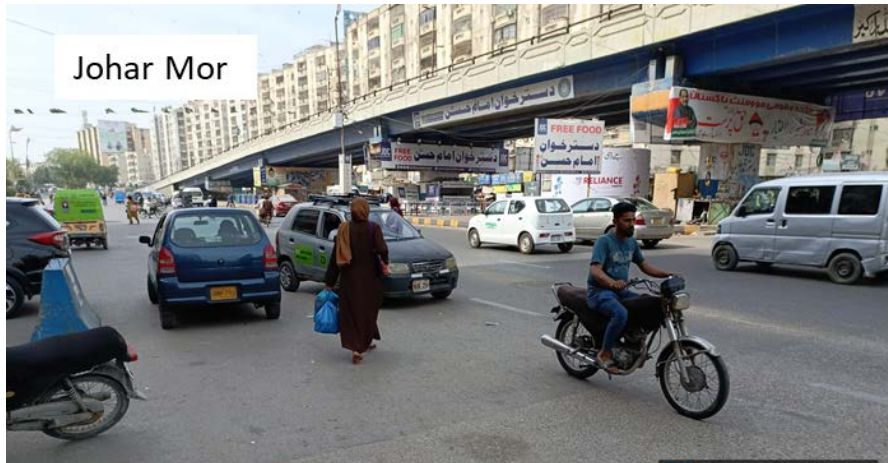
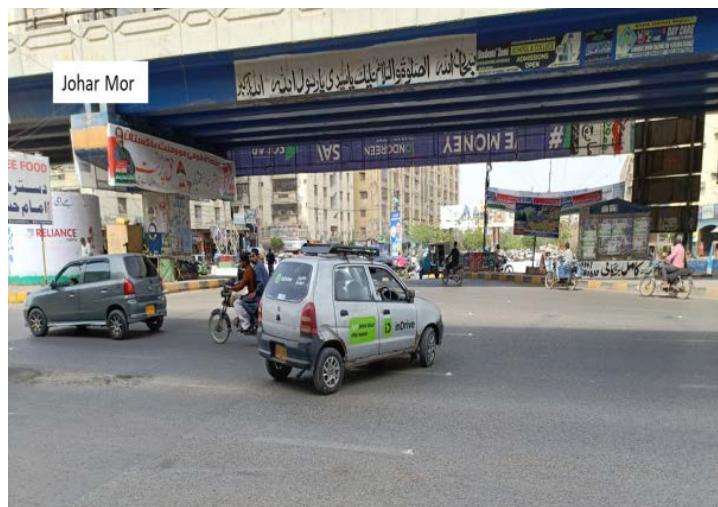
Defects Identified: Wrongway Movement

Short term: Strong Enforcement.

Medium term: The medium-term solution for wrong-way movement is to place U-turns at important locations.

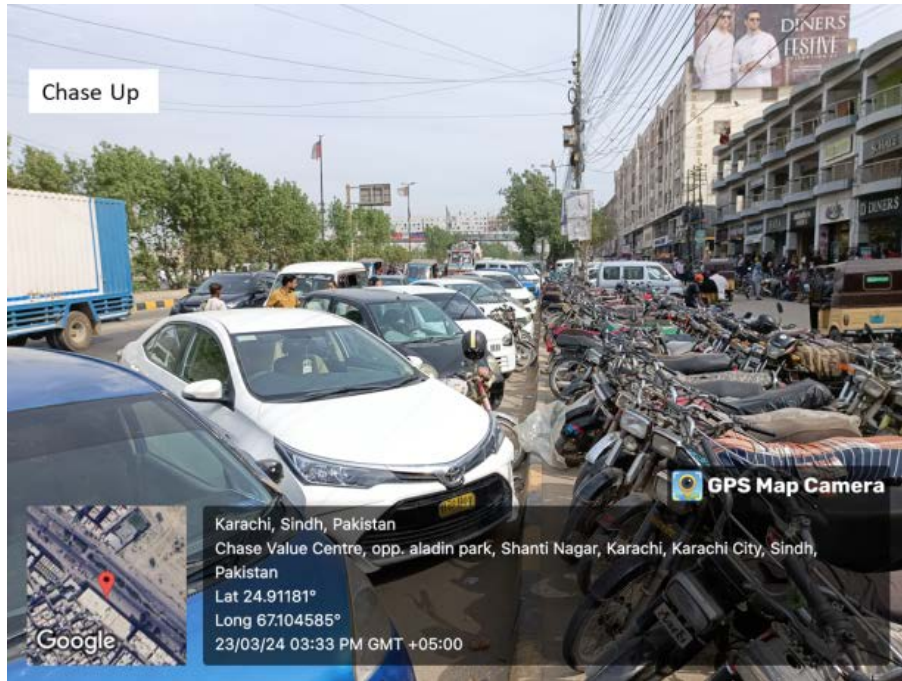
Defects Identified: On road Parking

Short term: Police challan.

Long term: Providing proper parking for vehicle.

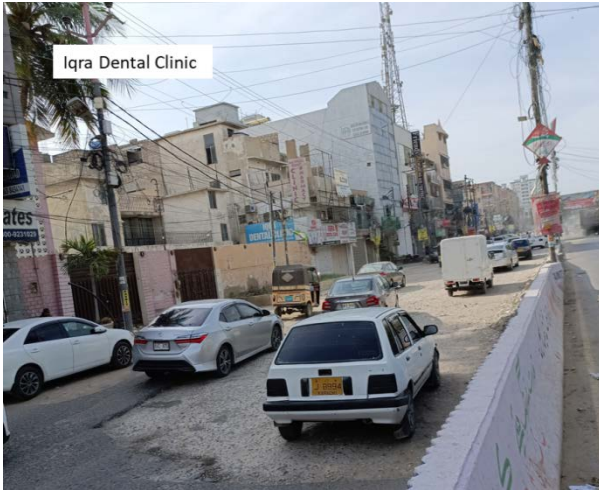
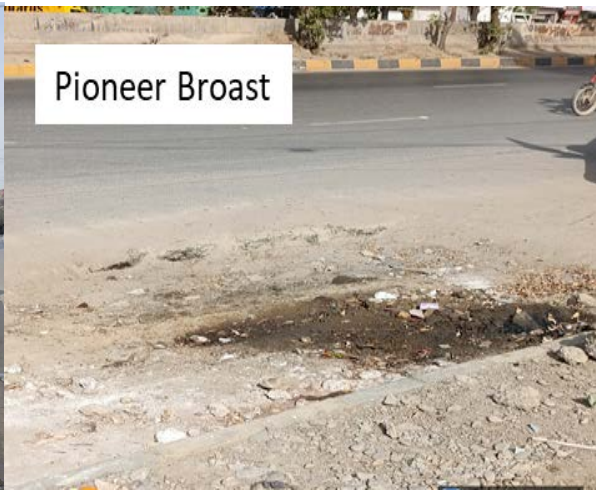
Defects Identified: Damaged Pavement

Short term: The short-term solution for potholes is to fill them.

Long term: The long-term solution is provision of a proper drainage system so that water does not remain stagnant (which is the main cause of potholes/ditches/pavement failure).

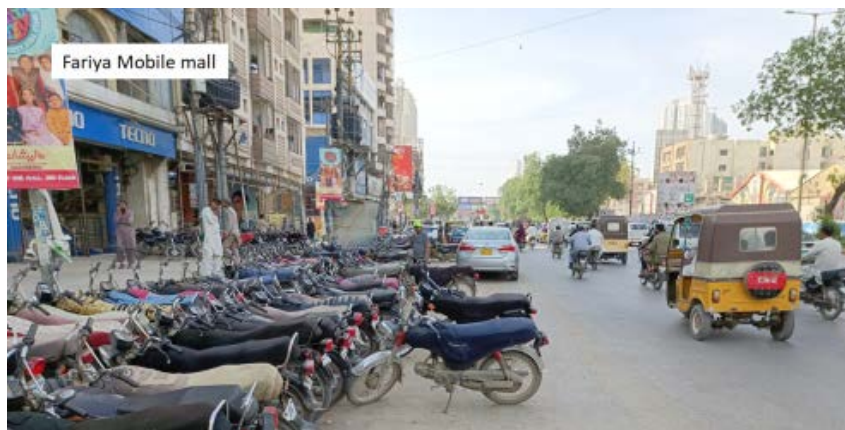
Defects Identified: Illegal Parking

Short term: Police challan.

Long term: Providing proper parking for vehicle.

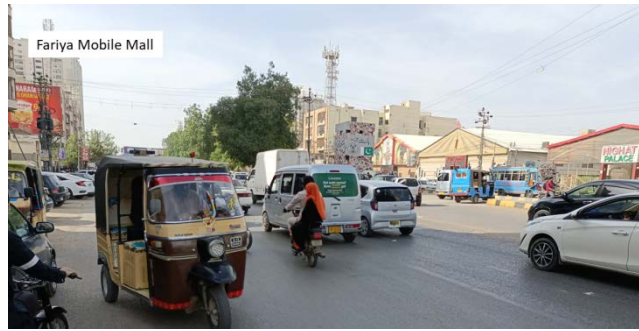
Defects Identified: Wrongway Movement

Short term: Strong Enforcement.

Medium term: The medium-term solution for wrong-way movement is to place U-turns at important locations.

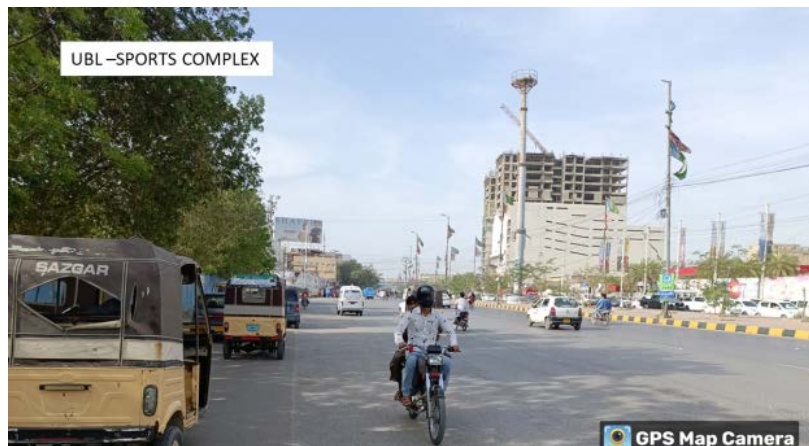
Defects Identified: Wrongway Movement

Short term: Strong Enforcement.

Medium term: The medium-term solution for wrong-way movement is to place U-turns at important locations.

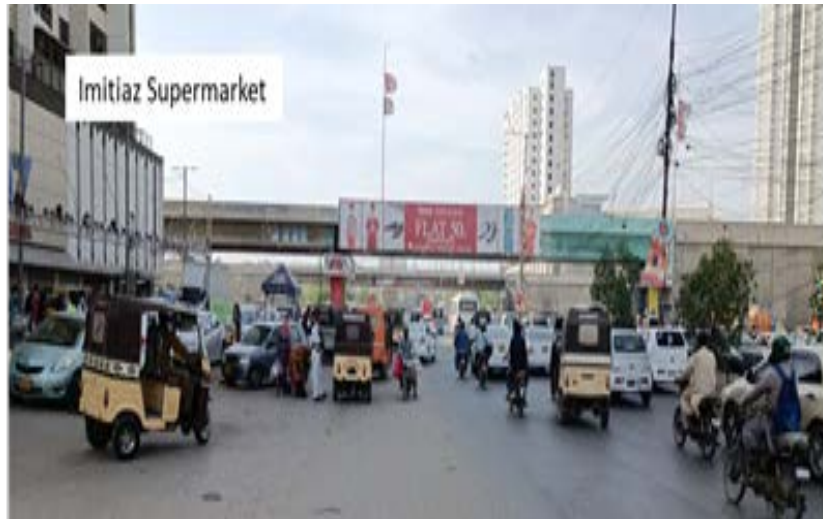
Defects Identified: Illegal Parking

Short term: Police challan.

Long term: Providing proper parking for vehicle.

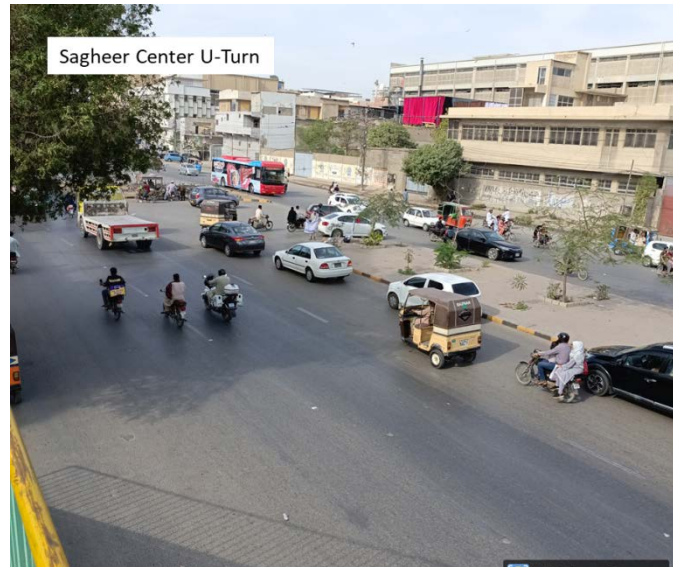
Defects Identified: Sudden U-turn

Short term: Provide traffic signage indicating u-turn ahead

Medium term: provide road safety studs to separate the turning traffic and through traffic

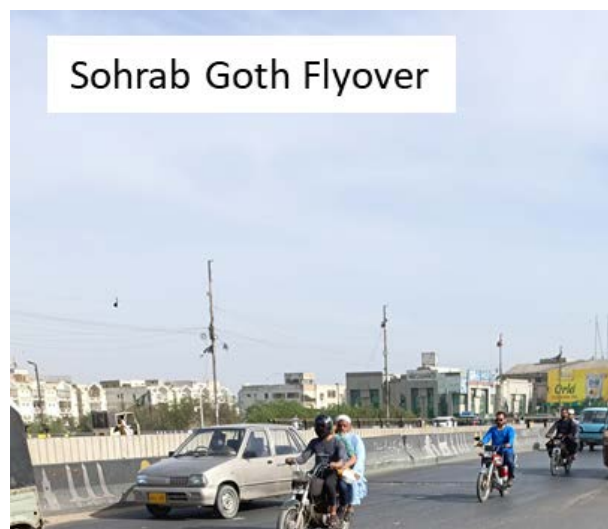
Defects Identified: Stolen guard rails of Flyover

Short term: Immediate action of police required to ensure infrastructure safety

Medium term: provide not sellable item for guard rails instead of using steel

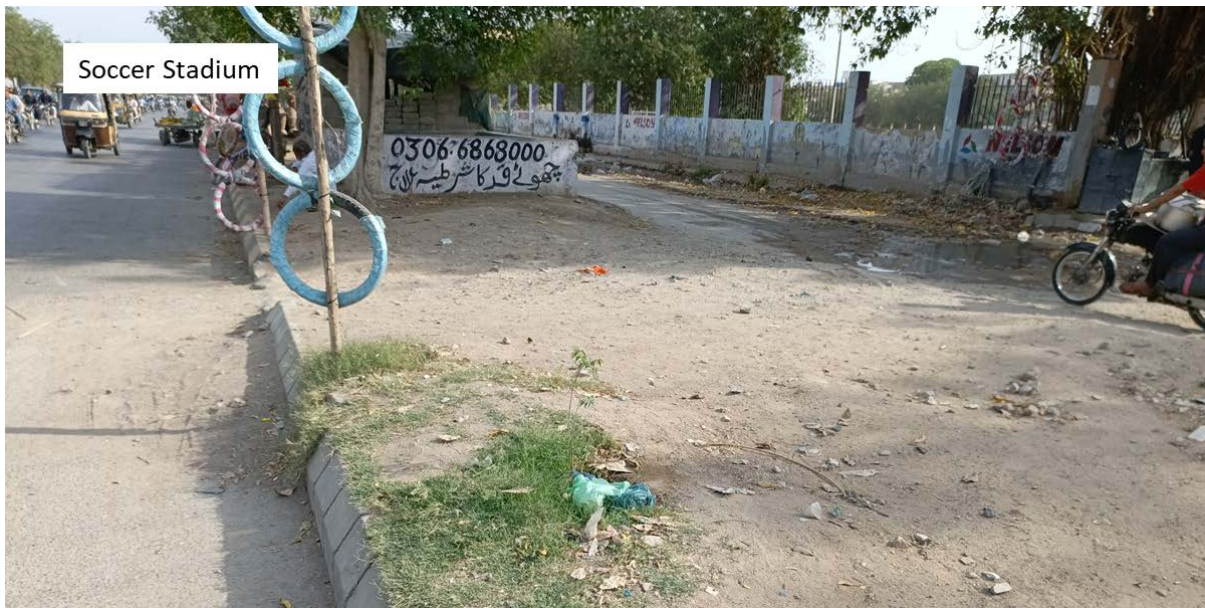
Defects Identified: sand and debris on footpath

Short term: remove the sand and garbage to make it usable for pedestrians

Medium term: install pavers for easy movement

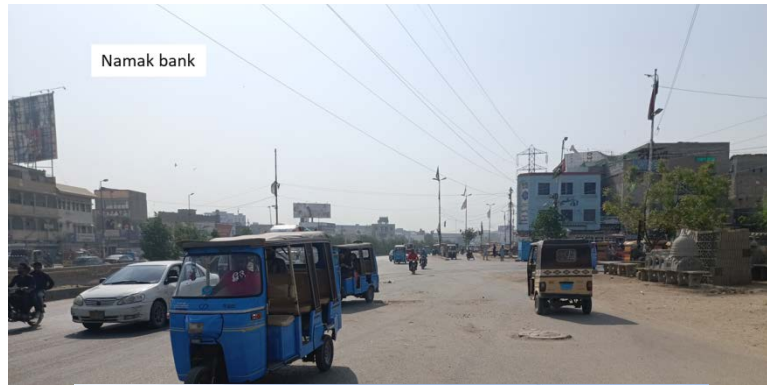
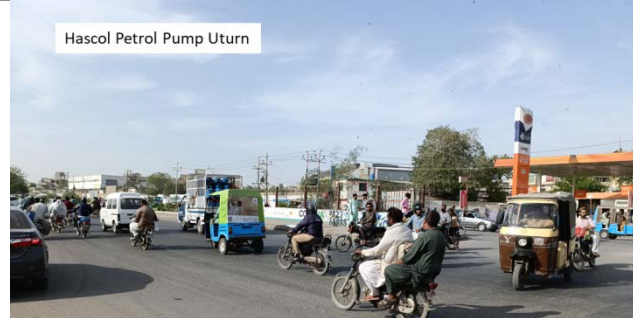
Defects Identified: Wrongway Movement

Short term: Strong Enforcement.

Medium term: The medium-term solution for wrong-way movement is to place U-turns at important locations.

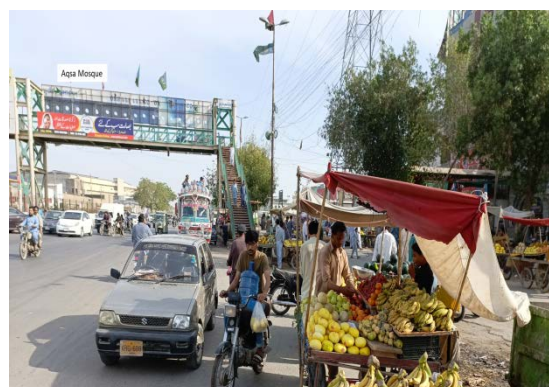
Defects Identified: Encroachment

Short term: Immediate removal of encroachments through enforcement actions, such as Police challan or eviction notices, to clear the affected areas.

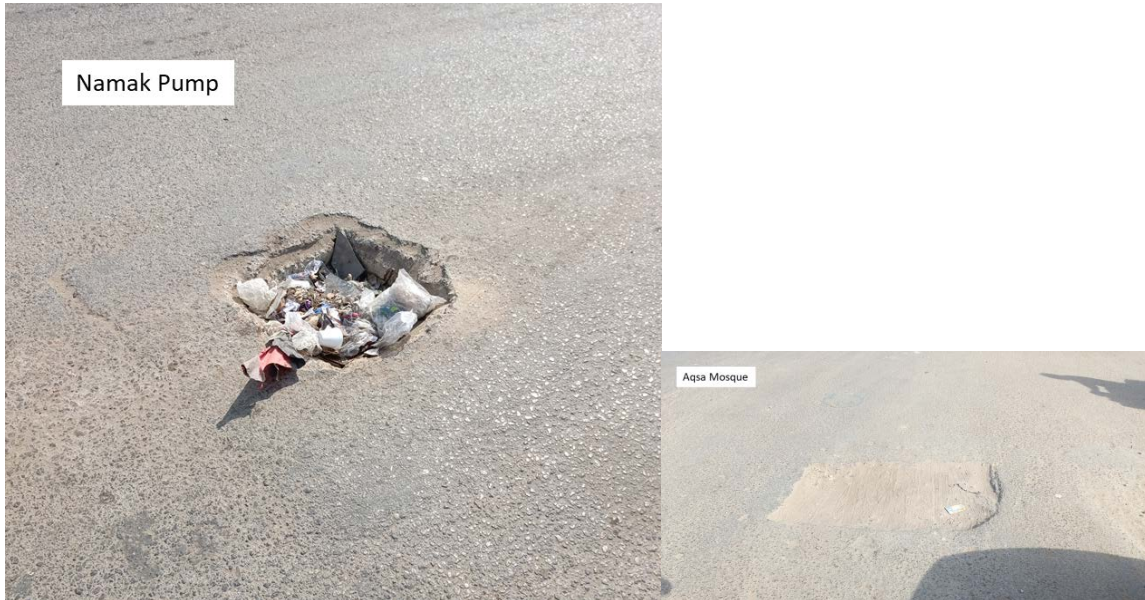
Defects Identified: Pothole/Ditches

Short term: The short-term solution for potholes is to fill them.

Long term: The long-term solution for potholes is to perform surfacing or overlay of the road surface.

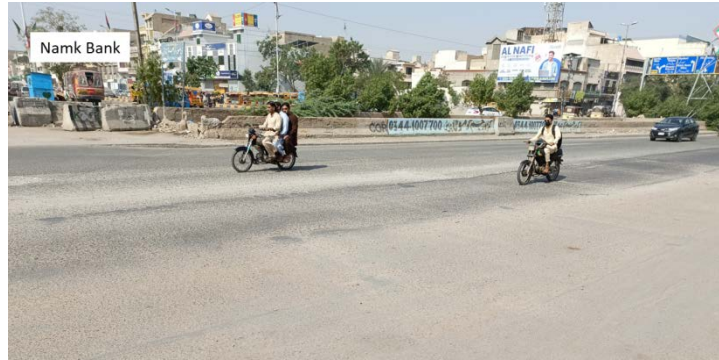
Defects Identified: Broken wall of nala

Medium term: The medium-term solution for broken wall of Nala is to pace NJ barriers to cover the opening.

Long term: The long-term solution is to construct a protective wall.

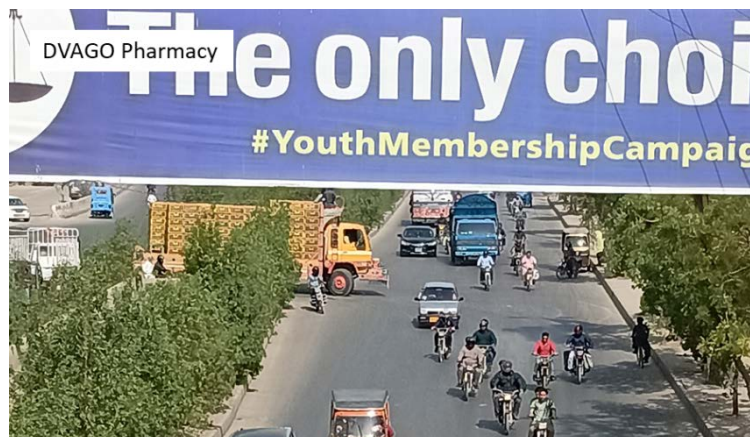
Defects Identified: Inadequate turning radii of u-turn

Long term: Provide protected u-turn with proper widening to ensure movement of heavy traffic

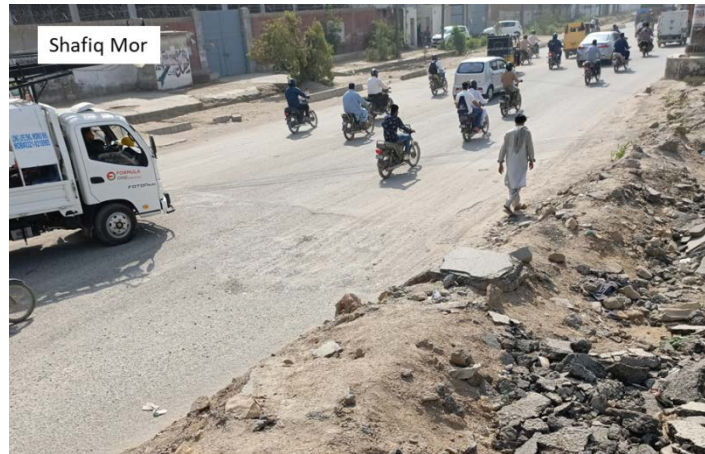
Defects Identified: Damaged Footpath/ Ditches

Short term: Remove the debris.

Long term: provide proper walkway with pavers

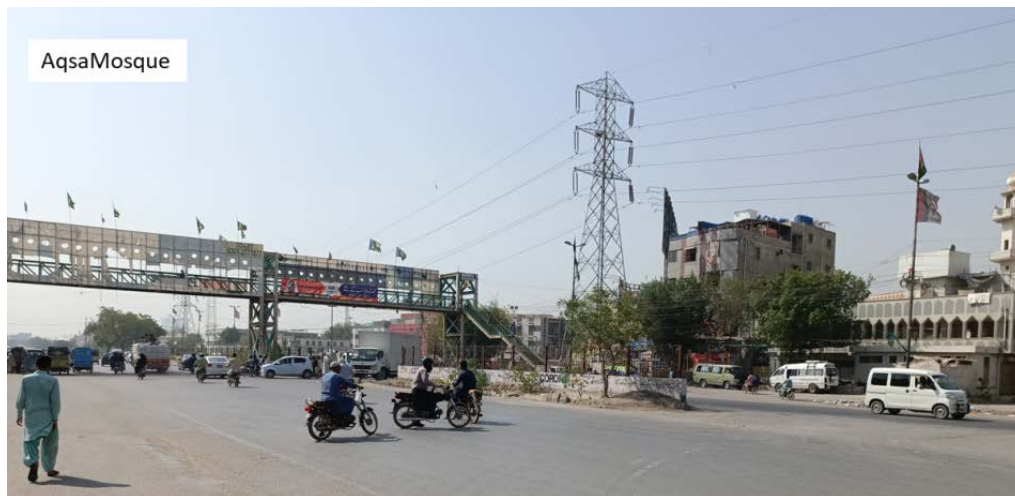
Defects Identified: Wrongway Movement

Short term: Strong Enforcement.

Medium term: The medium-term solution for wrong-way movement is to place U-turns at important locations.

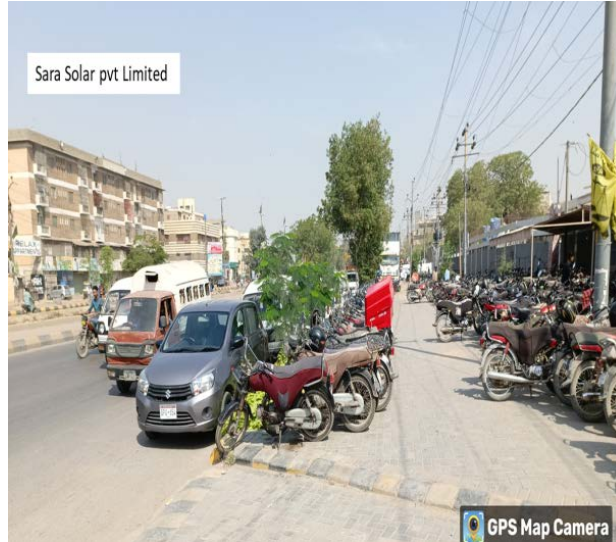
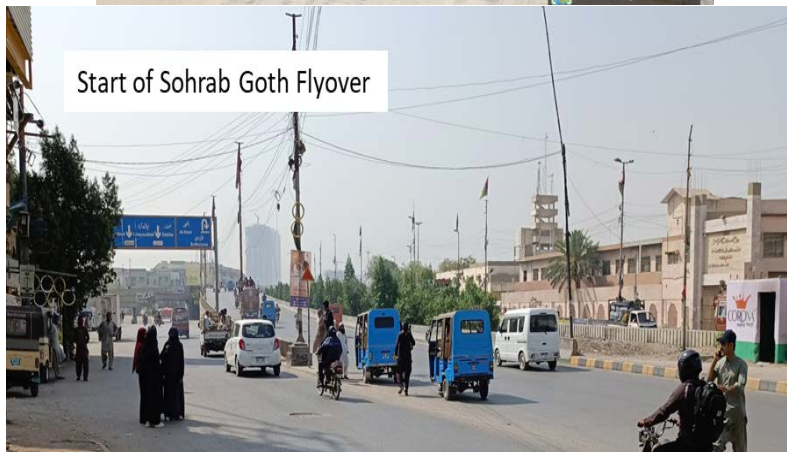
Defects Identified: On road Parking

Short term: Police challan.

Long term: Providing proper parking for vehicle.

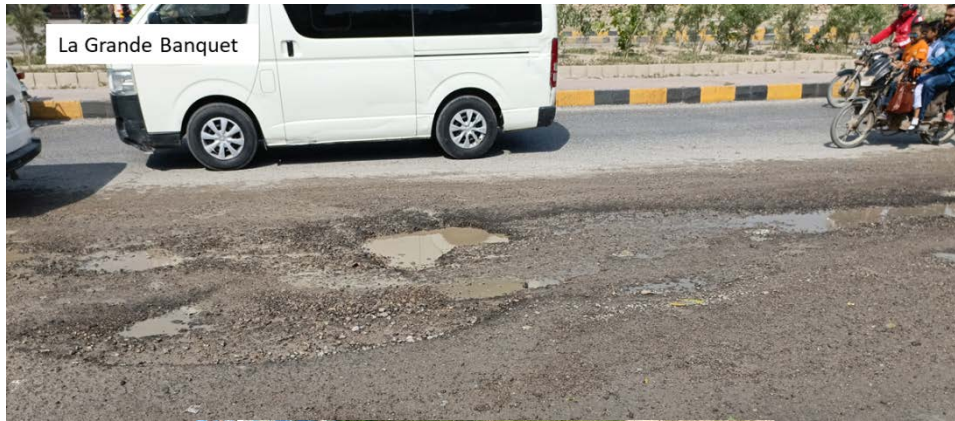
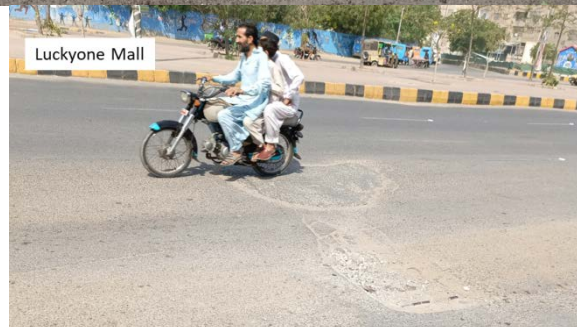
Defects Identified: Pothole/ Ditches

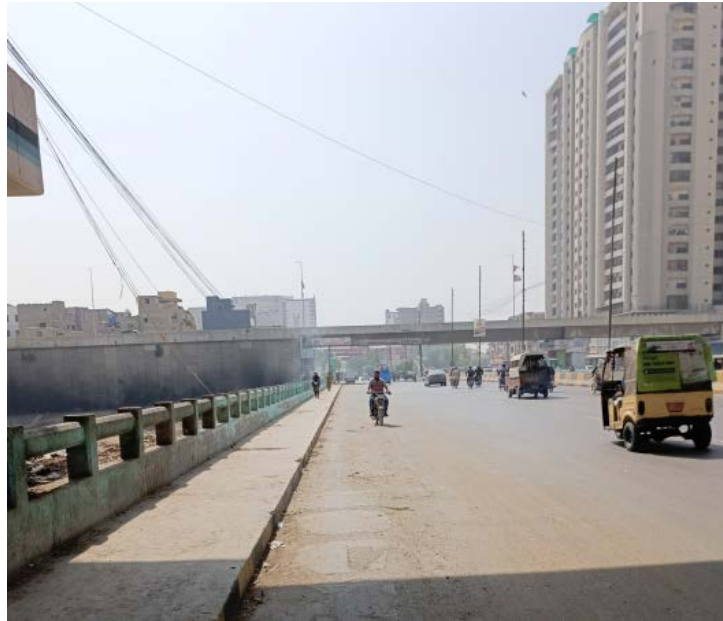
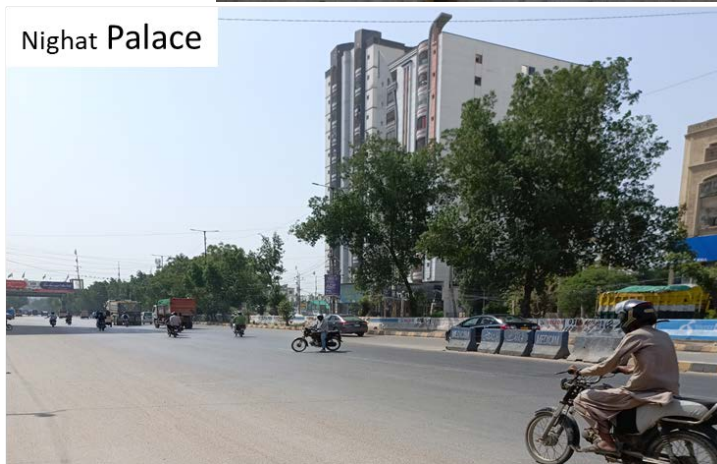
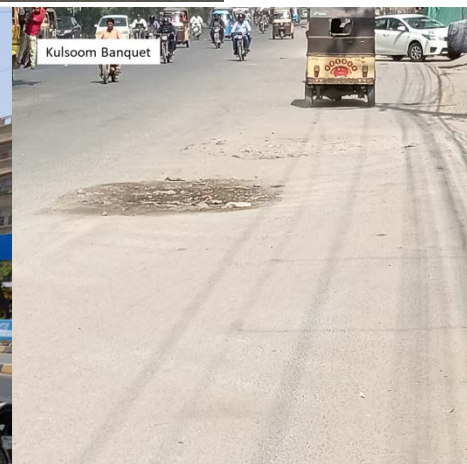
Defects Identified: Wrongway Movement

Short term: Strong Enforcement.

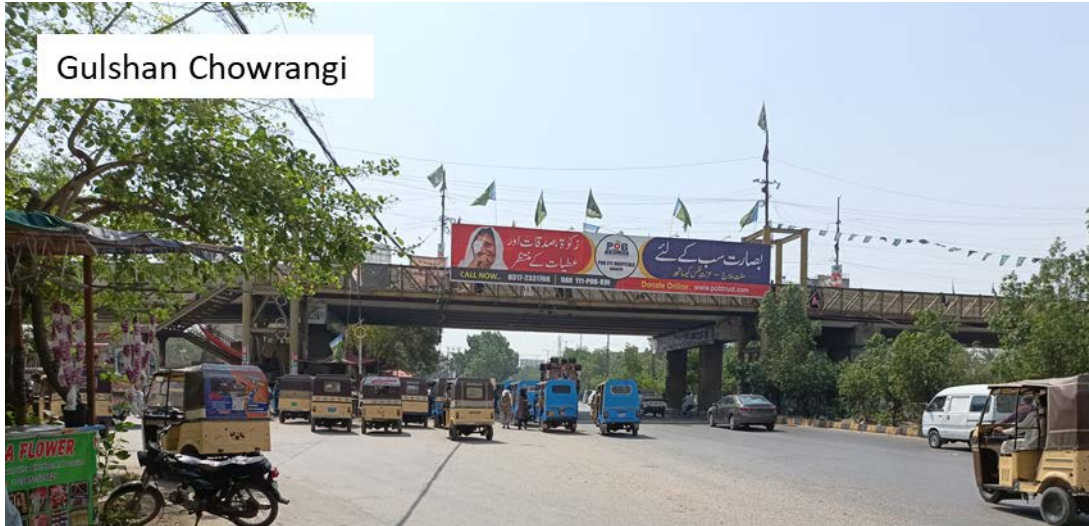
Gulshan Chowrangi

Defects Identified: On-road parking

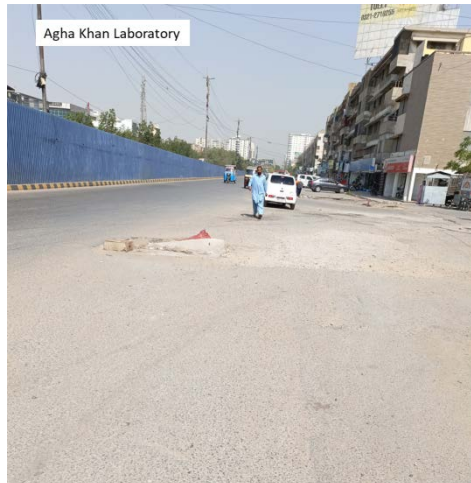
Defects Identified: Pothole/ Ditches

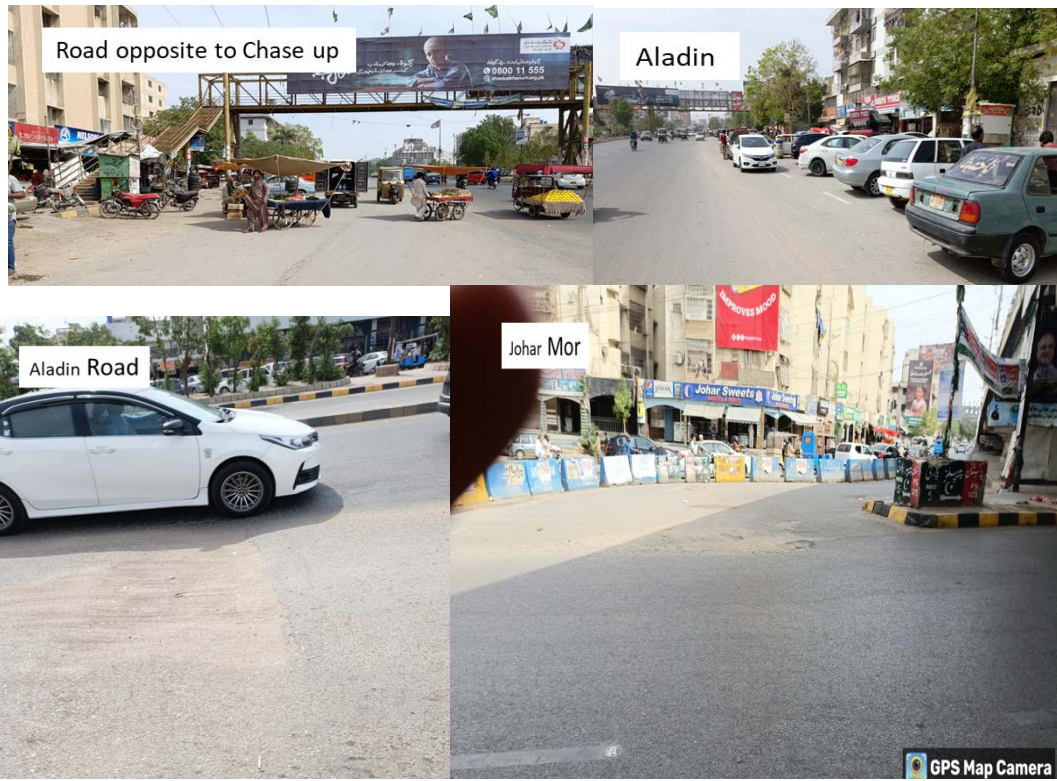
Defects Identified: Encroachment

Short term: Immediate removal of encroachments through enforcement actions, such as Police challan or eviction notices, to clear the affected areas.

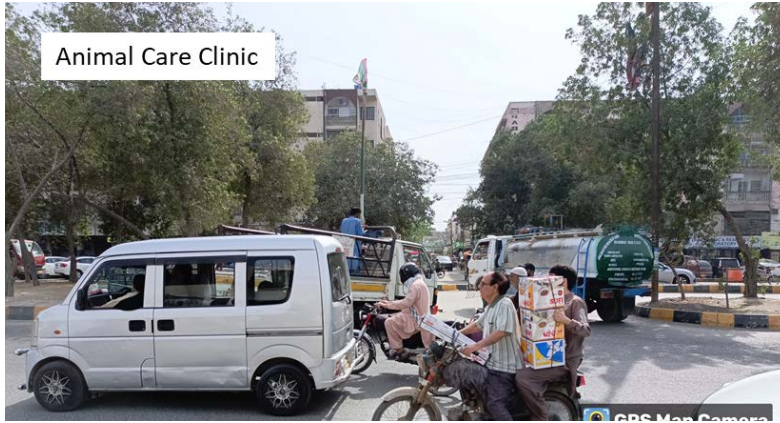
Defects Identified: Wrongway Movement

Short term: Strong Enforcement.

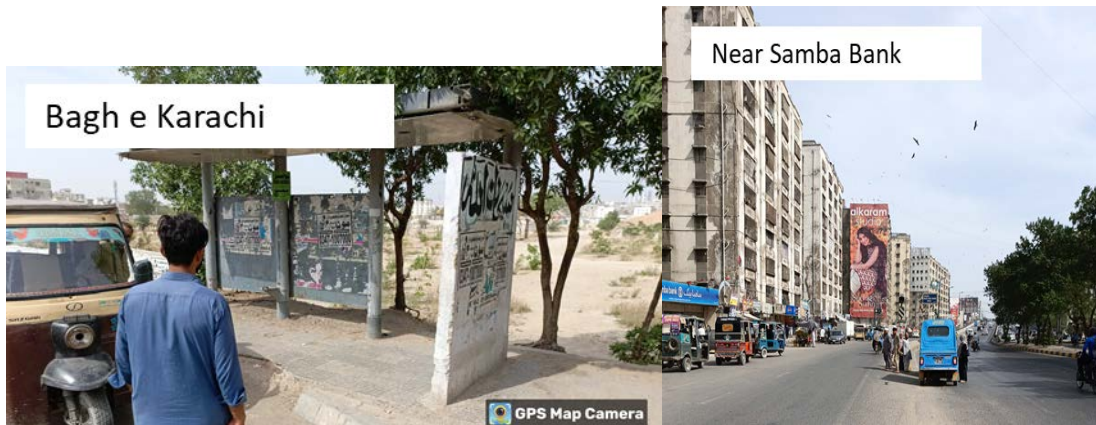
Defects Identified: Improper bus stops/ On road parking

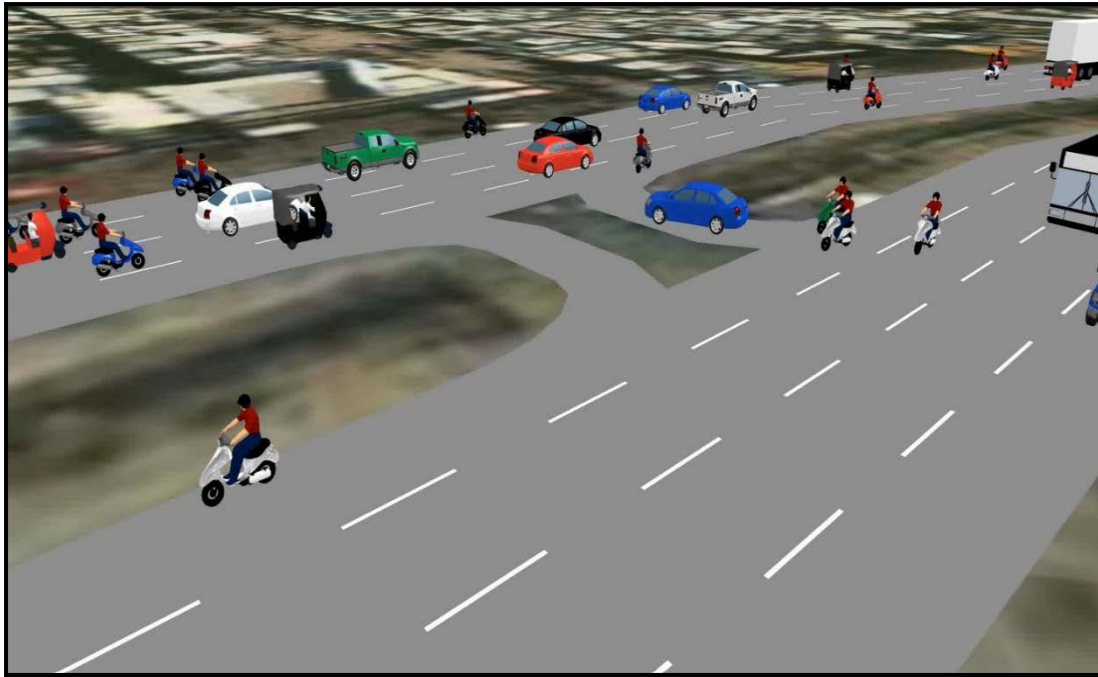
Figure 10 Rashid Minhas Road 3D traffic model

Table 4 illustrates the travel time from Millennium Mall to Nagan Chowrangi, divided into four segments for a detailed analysis of travel time for each segment. Initially, the travel time under free flow conditions was calculated, and then the current travel time was determined using VISSIM software. The difference between the current travel time is 3.5, 5.44, 0.96, and 3.78 minutes more than their respective free-flow times for segments 1, 2, 3, and 4, respectively. This table indicates that the current travel time deviates by an average of 13.70 minutes more than the free-flow time for all segments.

Table 4 also represents the travel time from Nagan Chowrangi to Drigh Road, and this route is also divided into four segments, each with the same free flow speed. The current travel time is then calculated, which averages 13.65 minutes more than the free-flow time for all segments. The current travel time of 2.30, 5.64, 1.84, and 3.87 minutes more than their respective free-flow times for each segment.
