TOYOTA ROAD IMPROVEMENT PROJECT (TRIP)

Sher Shah Suri Road and Nawab S. A. Khan Road

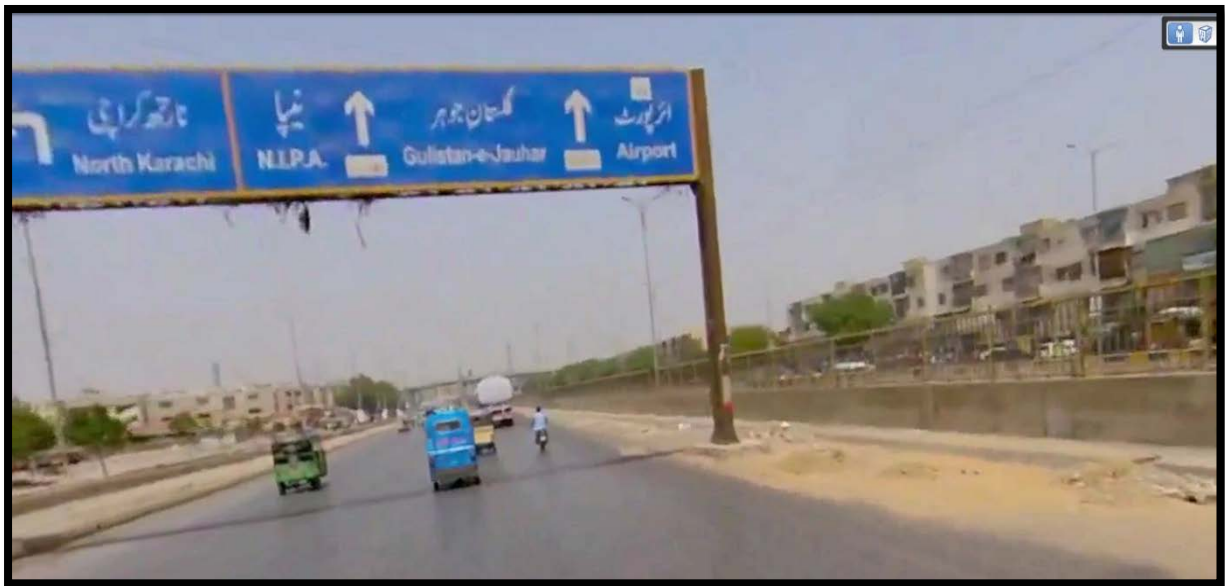
Figure 4 Pole in the fast lane before Nagan Chowrangi flyover.

The Pole of the Sign board is being erected in the middle of the fast lane while moving from Sakhi Hassan to Nagan Chowrangi. While many accident are being occurred because of a unexpected sign board at the fast lane because the users are expecting to increase the speed of the vehicle to move upwards at the Nagan Flyover.

Short term: Utilization of reflectors, Proper signage of this pole at least 100 meter before.

Medium term: Not applicable

Long term: Remove this pole and proper design of the signage shall be done than this kind of pole doesn't come in between of lanes.

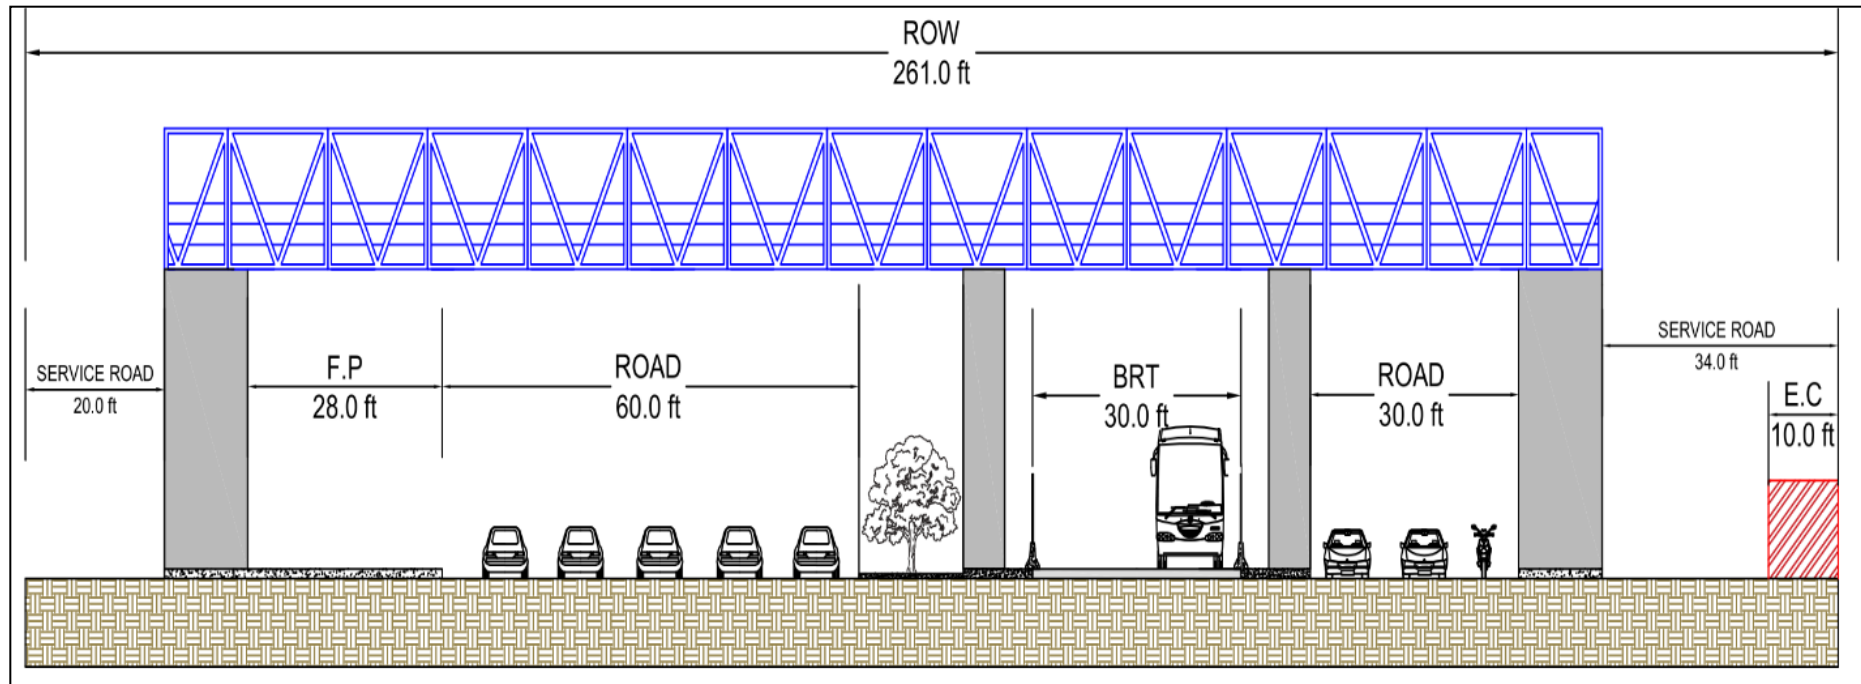
Figure 8 Cross-section of Nagan Chowranghi BRT Station

The Nagan Chowrangi BRT station there are two unequal carriageway widths i.e. 60 ft and 30 ft. The carriageway leading towards Nagan Chowrangi is visibly and severely narrowed which poses a great challenge for the road users due to its reduced width of mere 30.0 ft leading to potential traffic problems.

Long Term: Increase the width of carriageway by taking the portion of service road and also relocate the pedestrian bridge of BRT

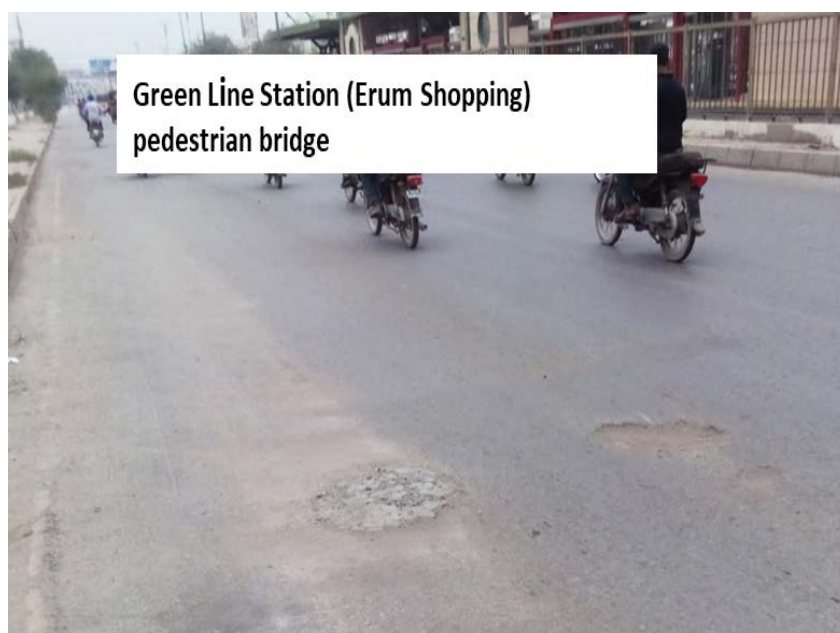
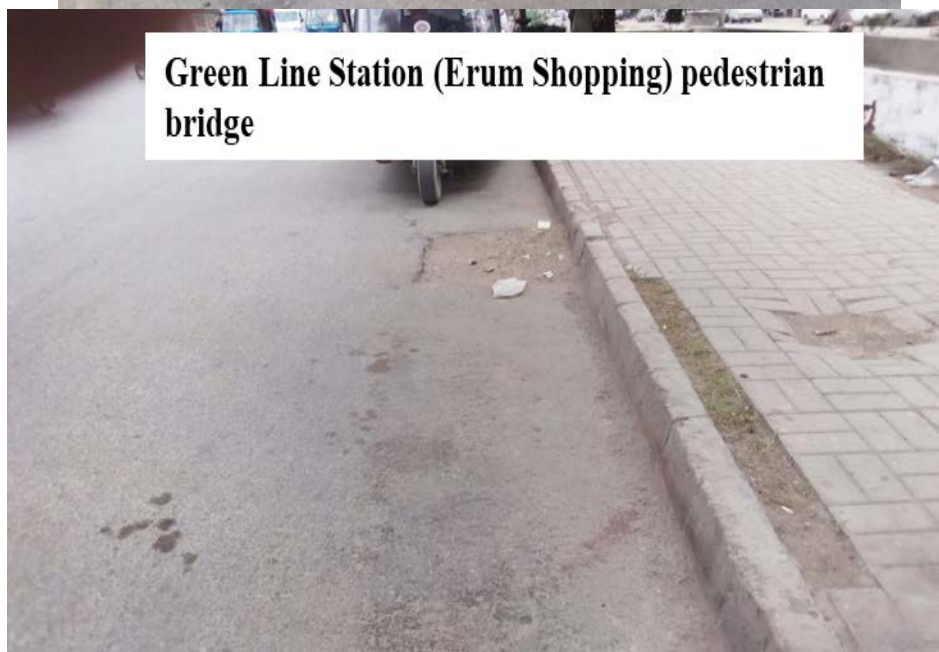
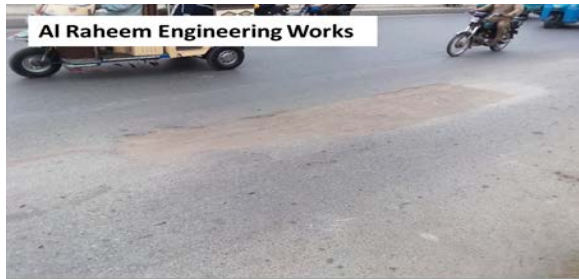
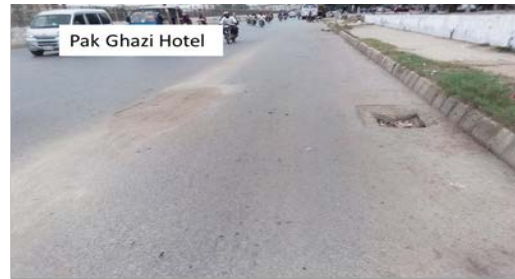
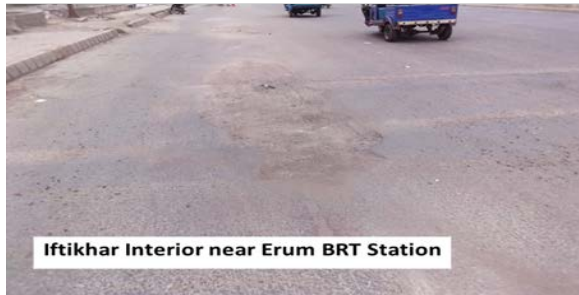
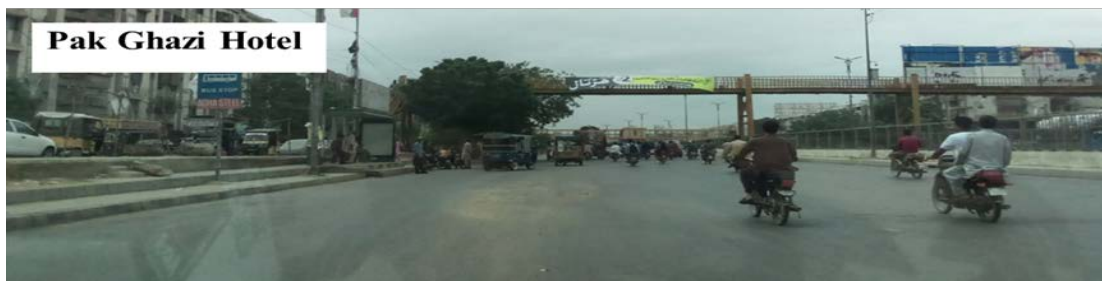
Defect Identified: Pothole/Ditches

Short term: The short-term solution for potholes is to fill them.

Long term: The long-term solution for potholes is to perform surfacing or overlay of the road surface.

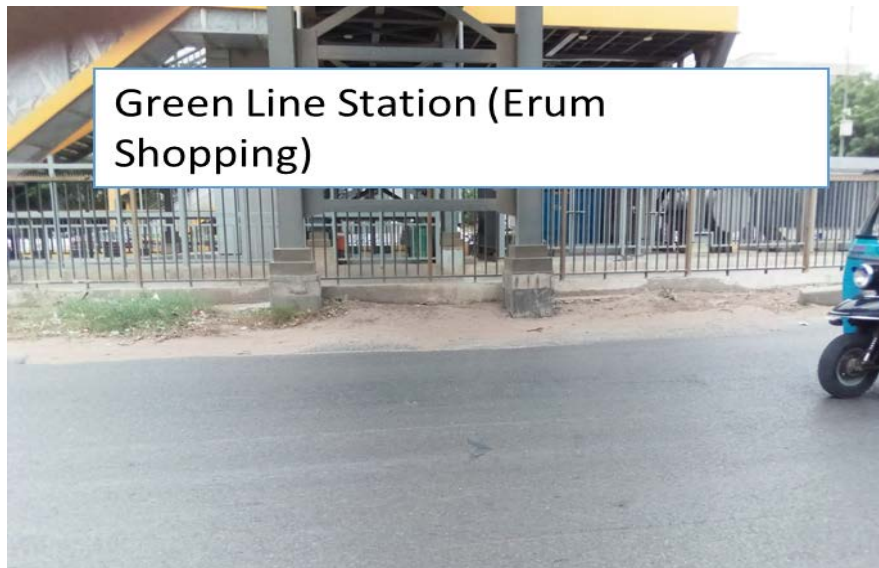
Defect Identified: Pedestrian Bridge extruding on fast lane

Short term: The short-term solution for the pedestrian bridge extruding onto the fast lane involves installing proper cat eyes and yellow markings for the road edge, along with fluorescent paint or sheeting, as well as road narrow ahead signage.

Long term: The long-term solution for the pedestrian bridge extruding onto the fast lane is to implement chamfered medians.

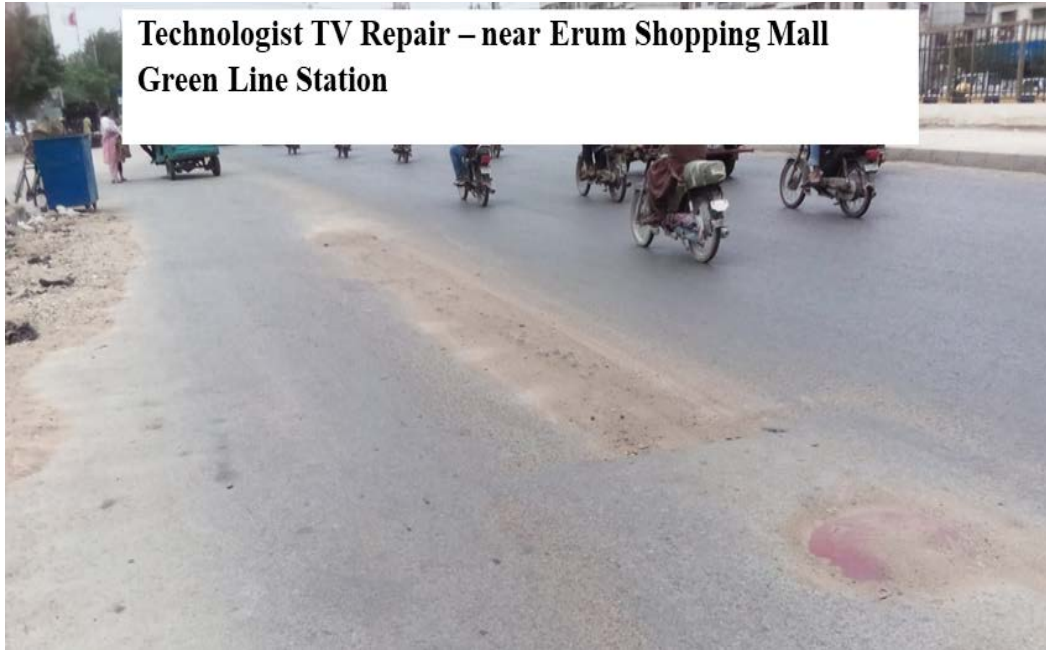
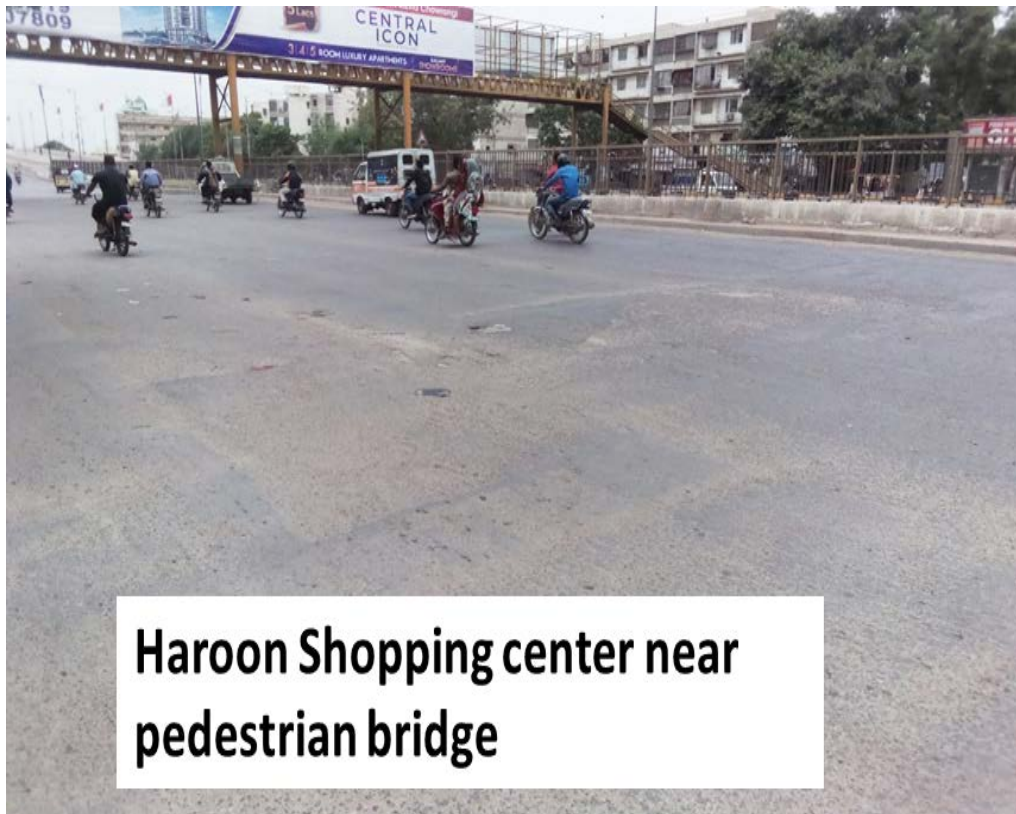
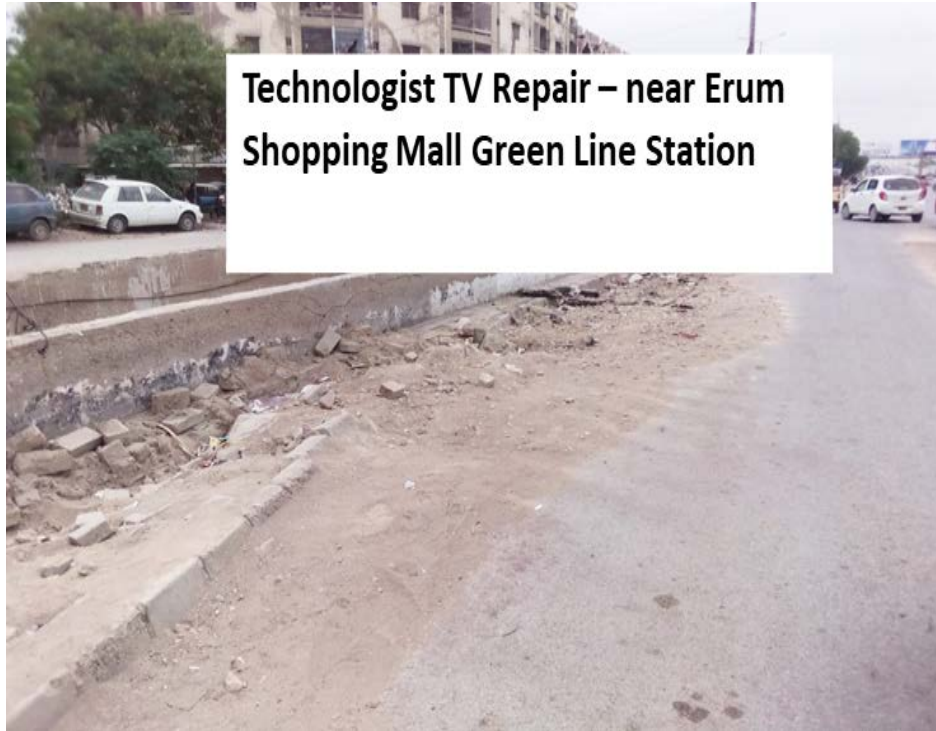
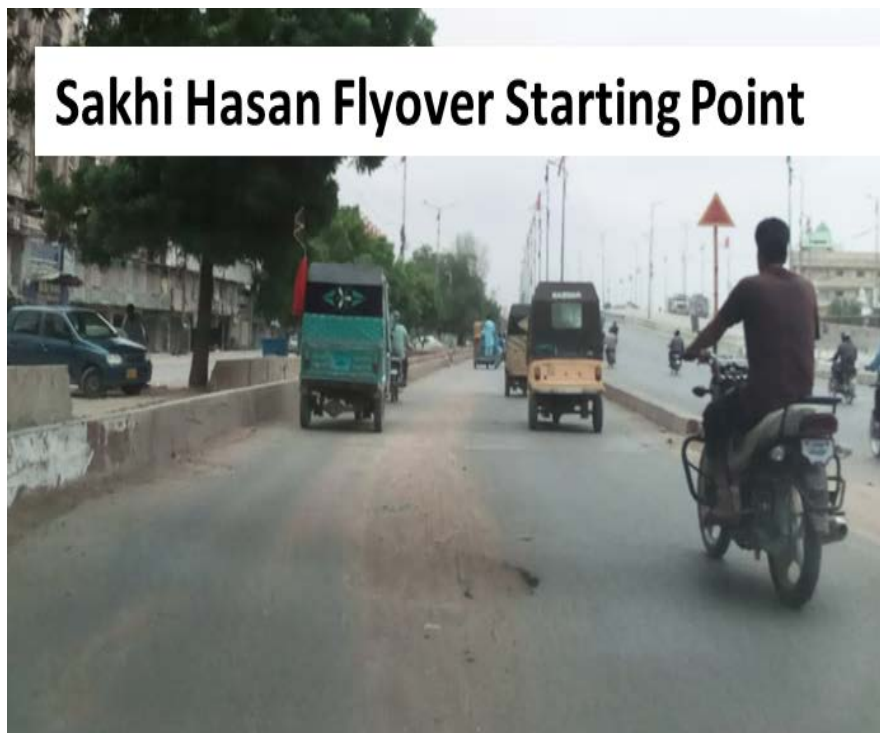
Defect Identified: Pothole/Ditches

Short term: The short-term solution for potholes is to fill them.

Long term: The long-term solution for potholes is to perform surfacing or overlay of the road surface.

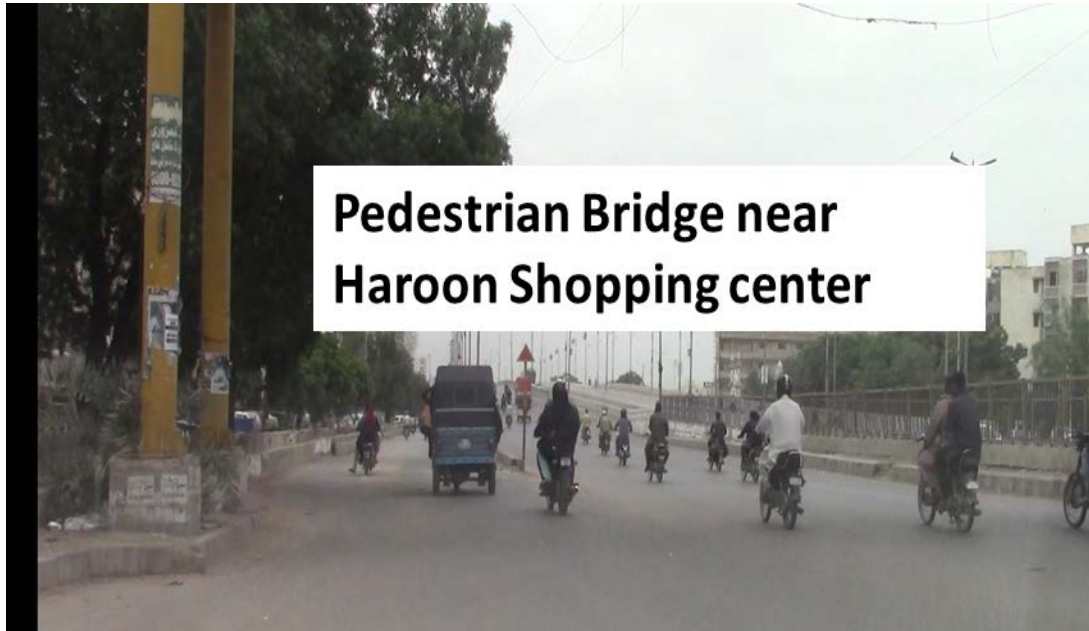
Defect Identified: Pedestrian Bridge extruding

Short term: The short-term solution for the pedestrian bridge extruding onto the fast lane involves installing proper cat eyes and yellow markings for the road edge, along with fluorescent paint or sheeting, as well as road narrow ahead signage.

Long term: The long-term solution for the pedestrian bridge extruding onto the fast lane is to implement chamfered medians.

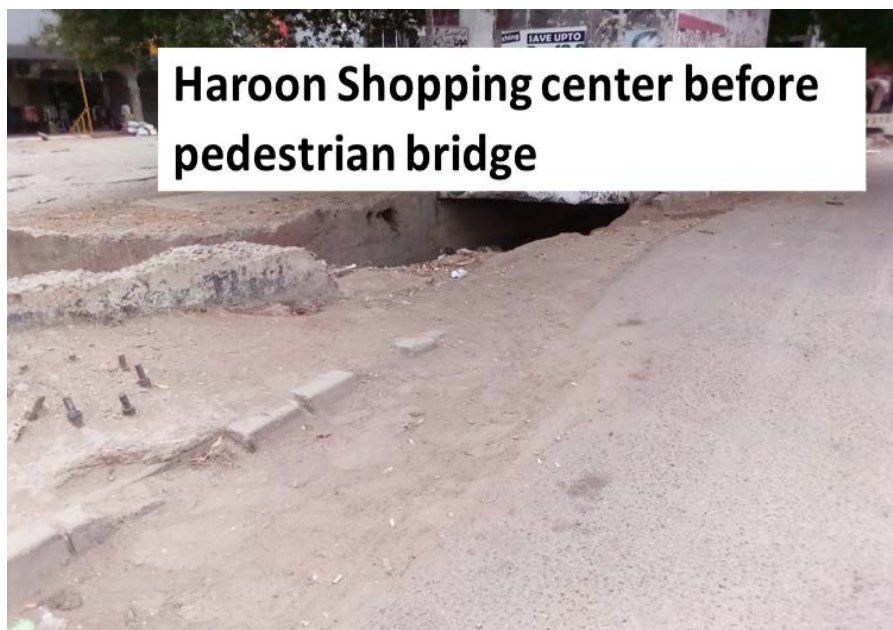
Defect Identified: Open Nala

Medium term: The medium-term solution for broken wall of Nala is to place NJ barriers to cover the opening.

Long term: The long-term solution is to construct a protective wall.

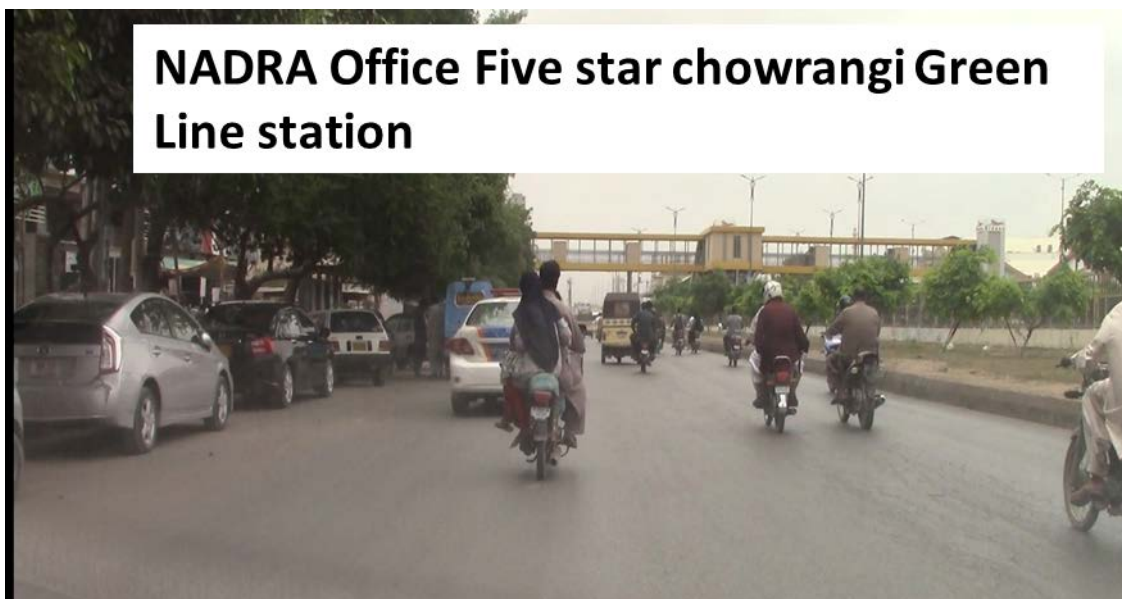
Defect Identified: Illegal Parking

Short term: Police challan.

Long term: Providing proper parking for vehicle.

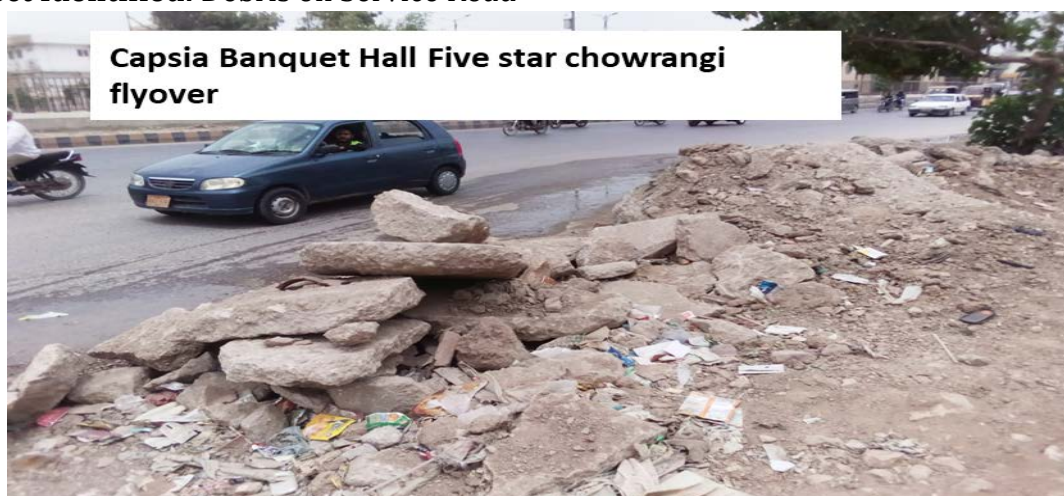
Defect Identified: Debris on Service Road

Short term: Increase frequency of road cleaning operations, deploy street sweepers regularly.

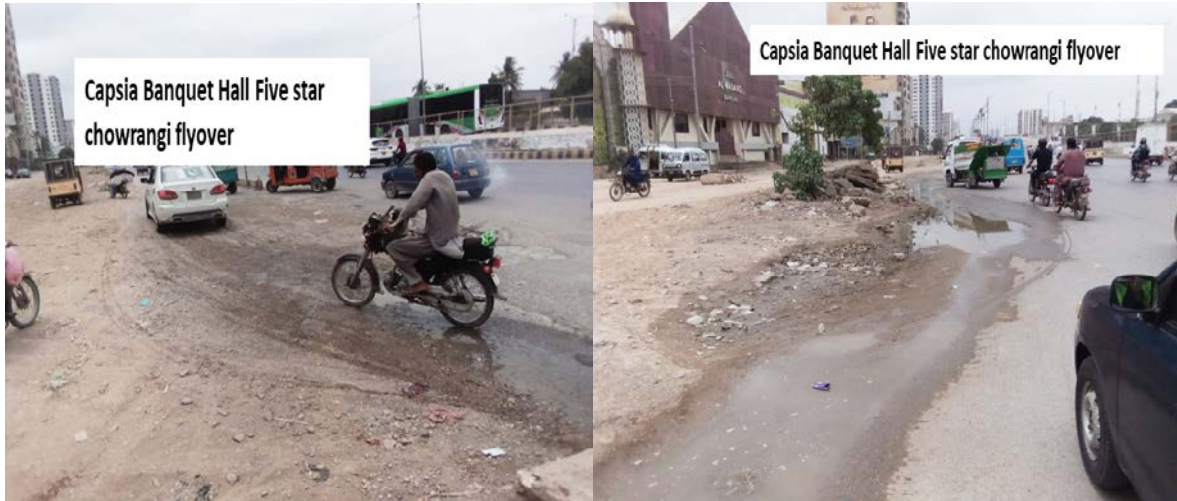
Defect Identified: Pothole/Ditches

Short term: The short-term solution for potholes is to fill them.

Long term: The long-term solution for potholes is to perform surfacing or overlay of the road surface.

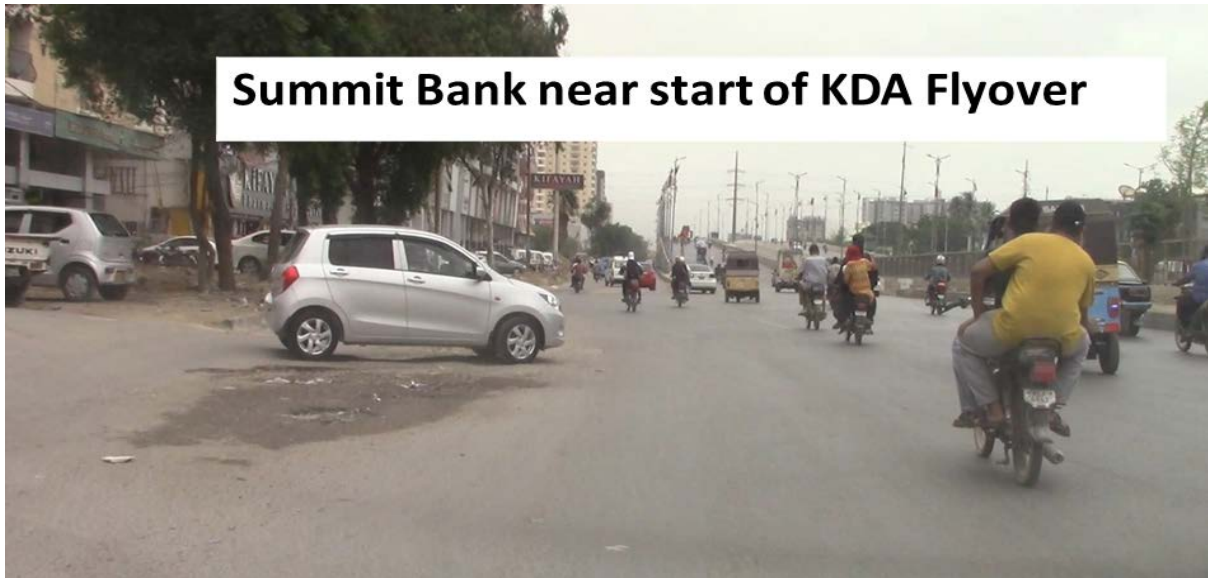
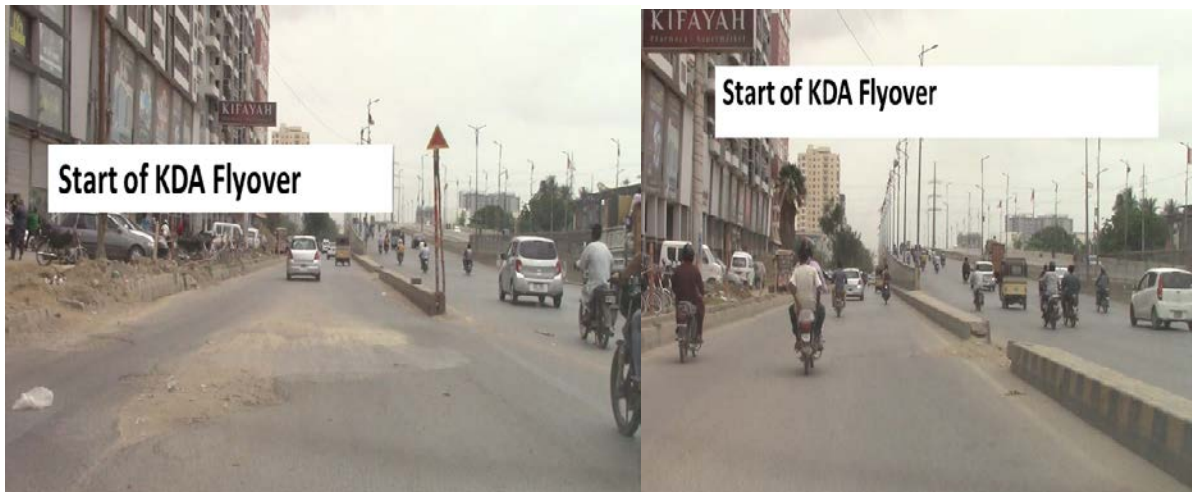
Defect Identified: Pothole/Ditches

Short term: The short-term solution for potholes is to fill them.

Long term: The long-term solution for potholes is to perform surfacing or overlay of the road surface.

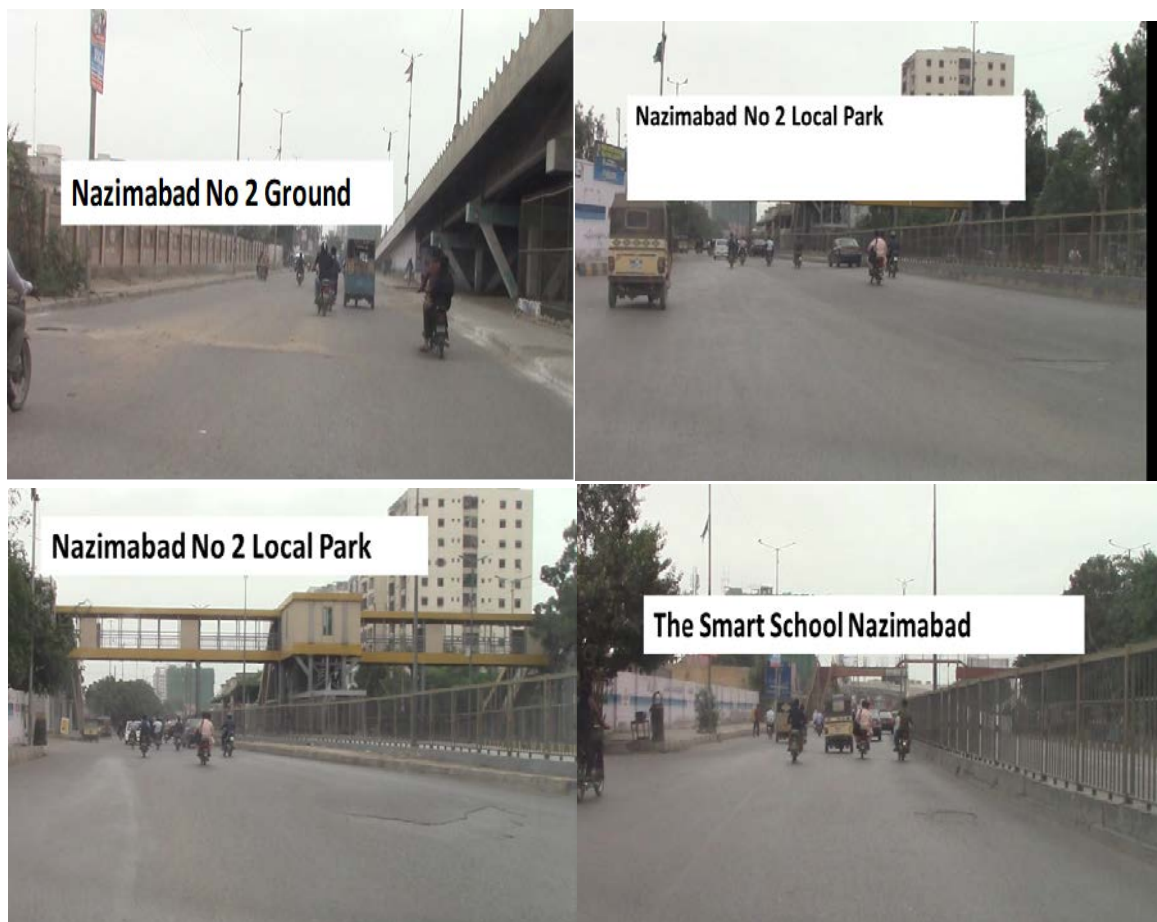
Defect Identified: Pothole/Ditches

Short term: The short-term solution for potholes is to fill them.

Long term: The long-term solution for potholes is to perform surfacing or overlay of the road surface.

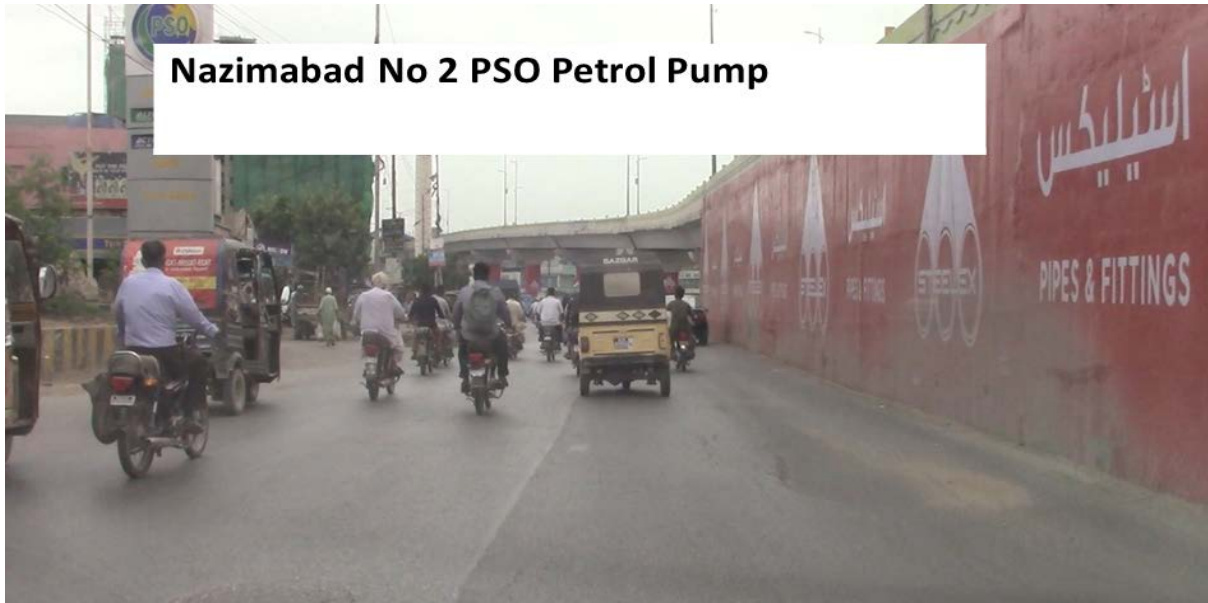
Defect Identified: Pothole/Ditches

Short term: The short-term solution for potholes is to fill them.

Long term: The long-term solution for potholes is to perform surfacing or overlay of the road surface.

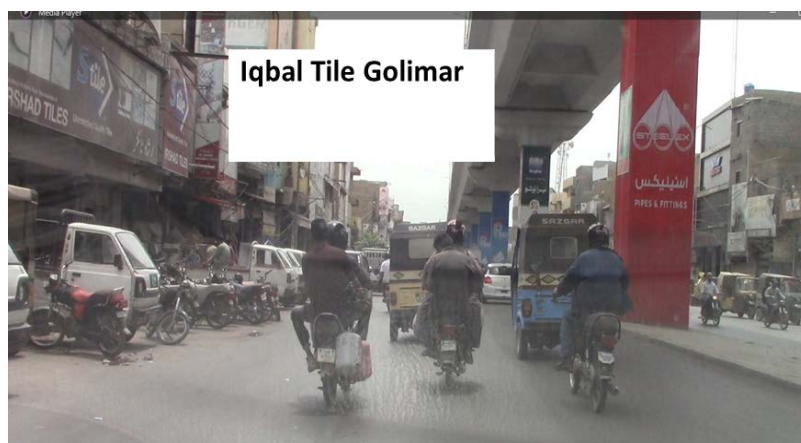
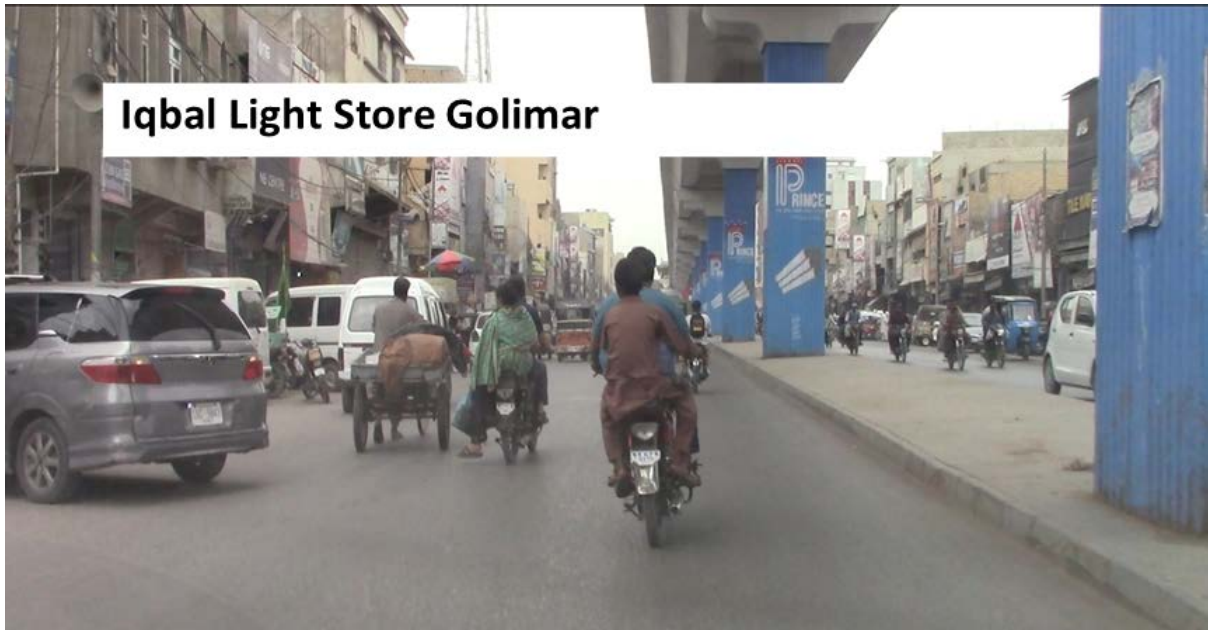
Defect Identified: Illegal Parking

Short term: Police challan.

Long term: Providing proper parking for vehicle.

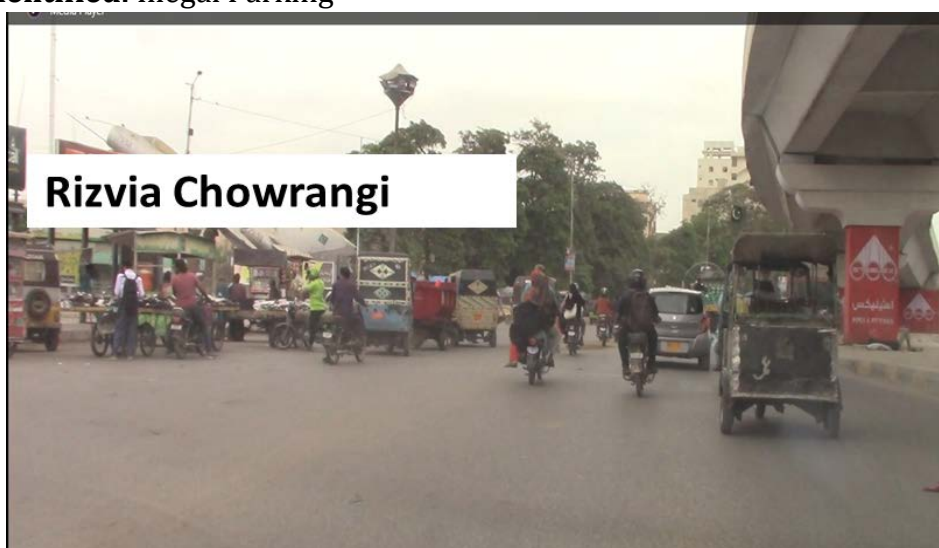
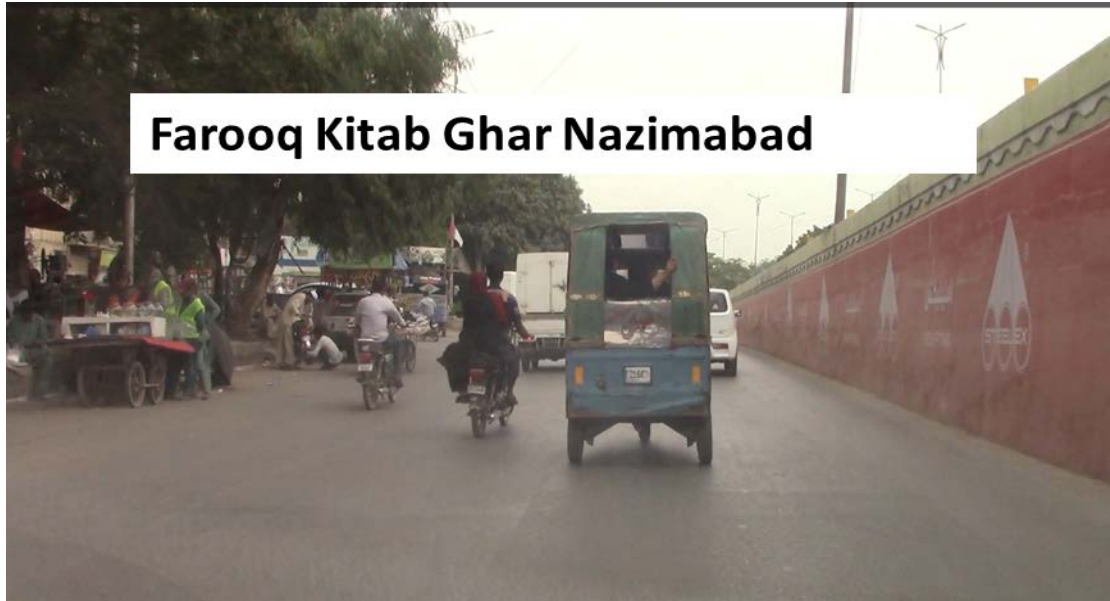
Defect Identified: Illegal Parking

Short term: Police challan.

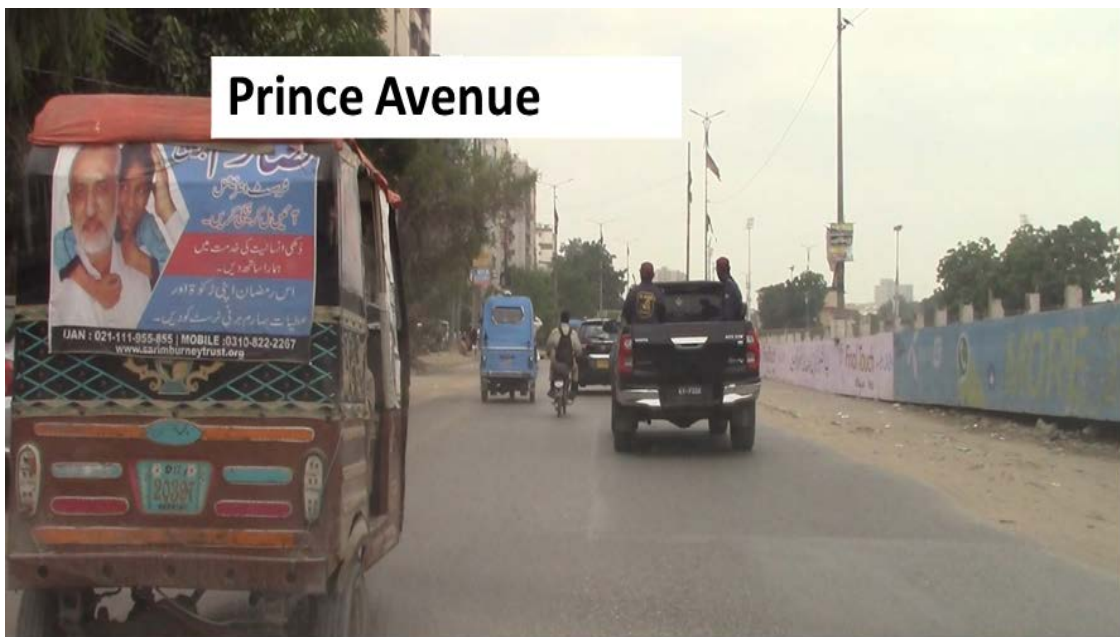
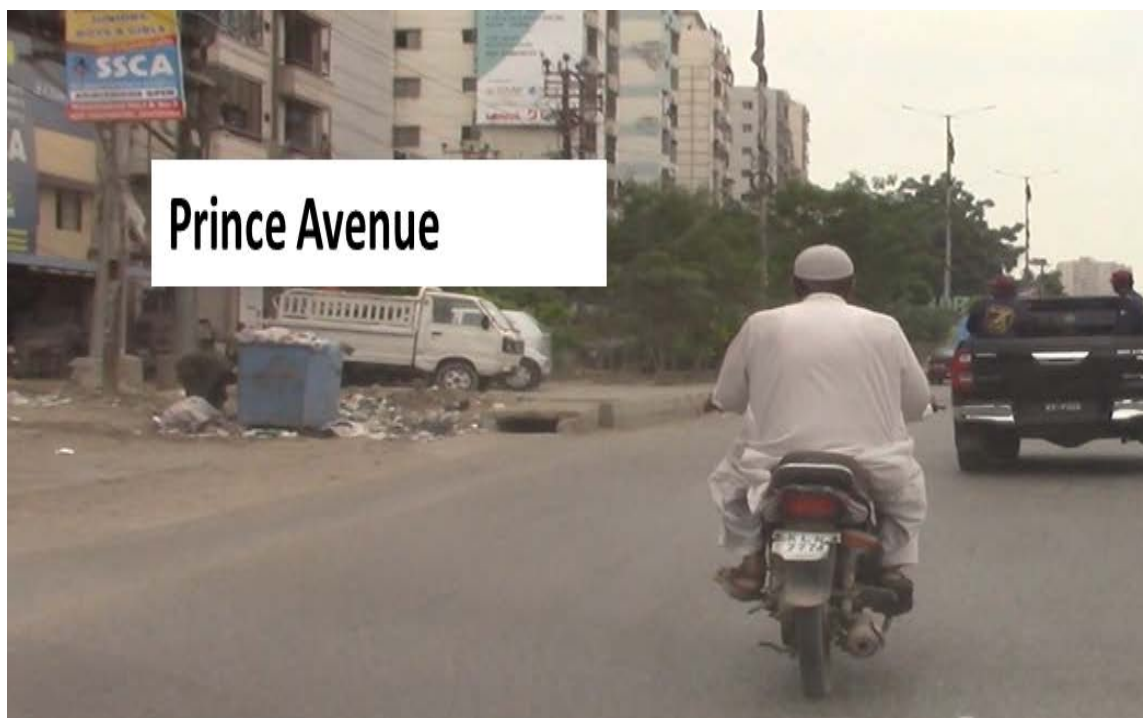
Defect Identified: Debris

Short term: Increase frequency of road cleaning operations, deploy street sweepers regularly.

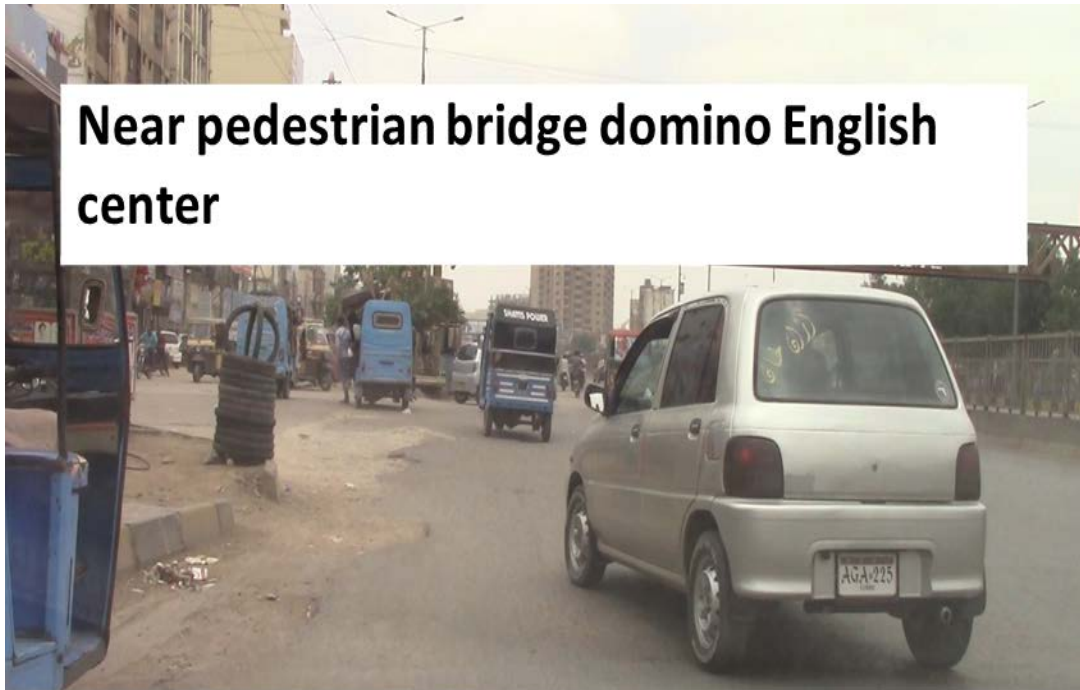
Defect Identified: Pothole/Ditches

Long term: The long-term solution for potholes is to perform surfacing or overlay of the road surface.

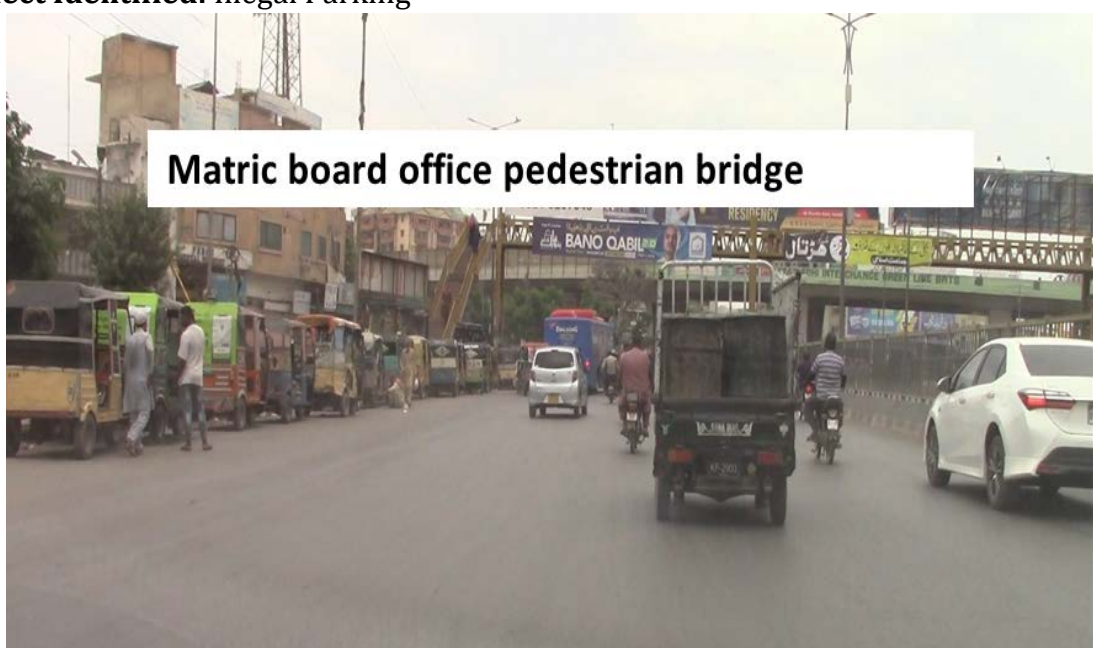
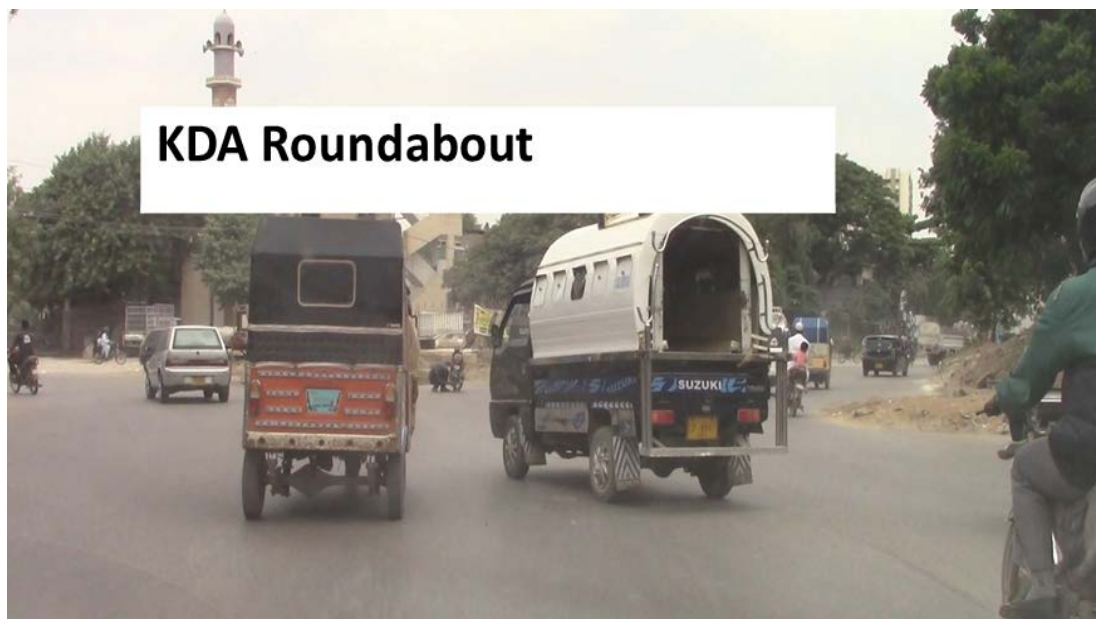
Defect Identified: Illegal Parking

Short term: Police challan.

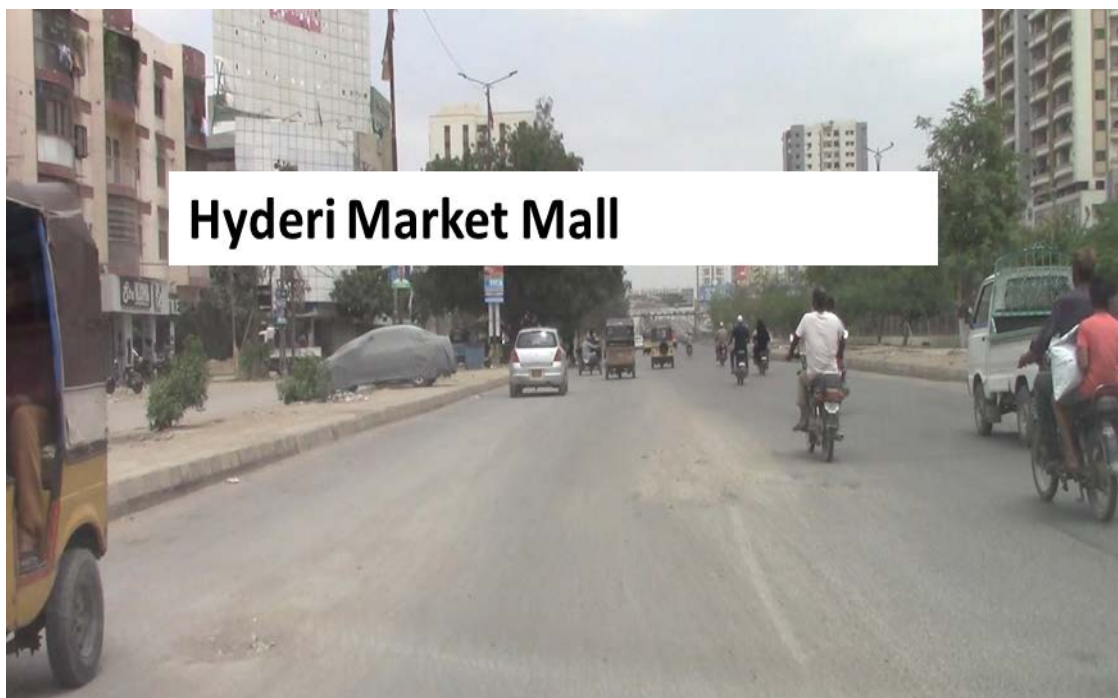
Defect Identified: Pothole/Ditches

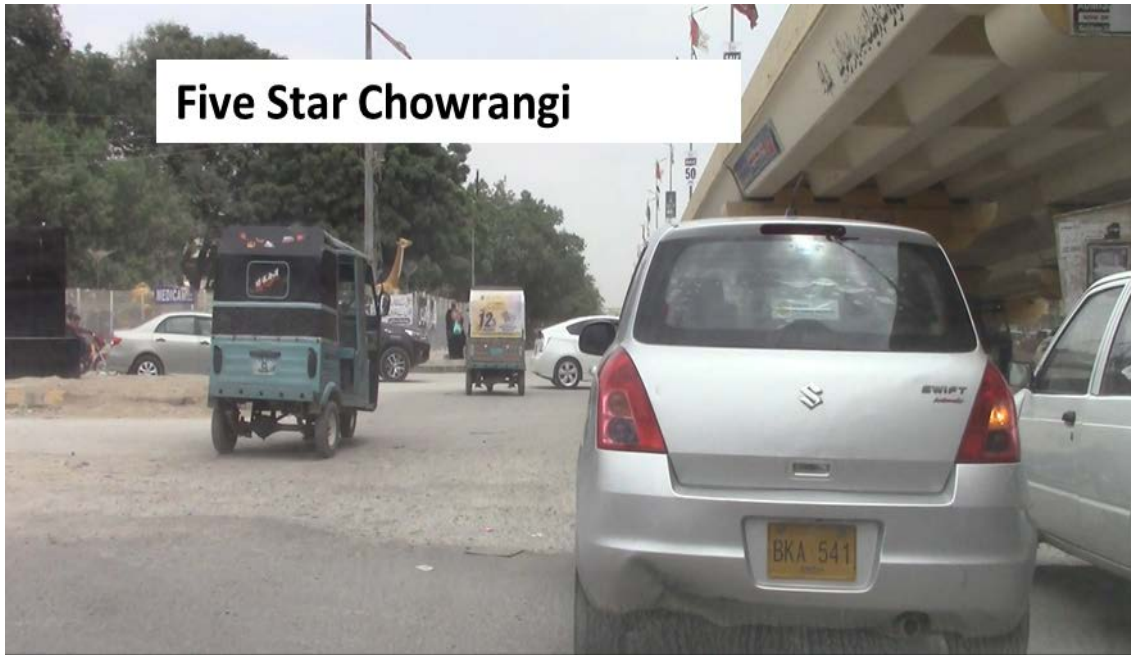
Five Star Chowrangi

Defect Identified: Pothole/Ditches

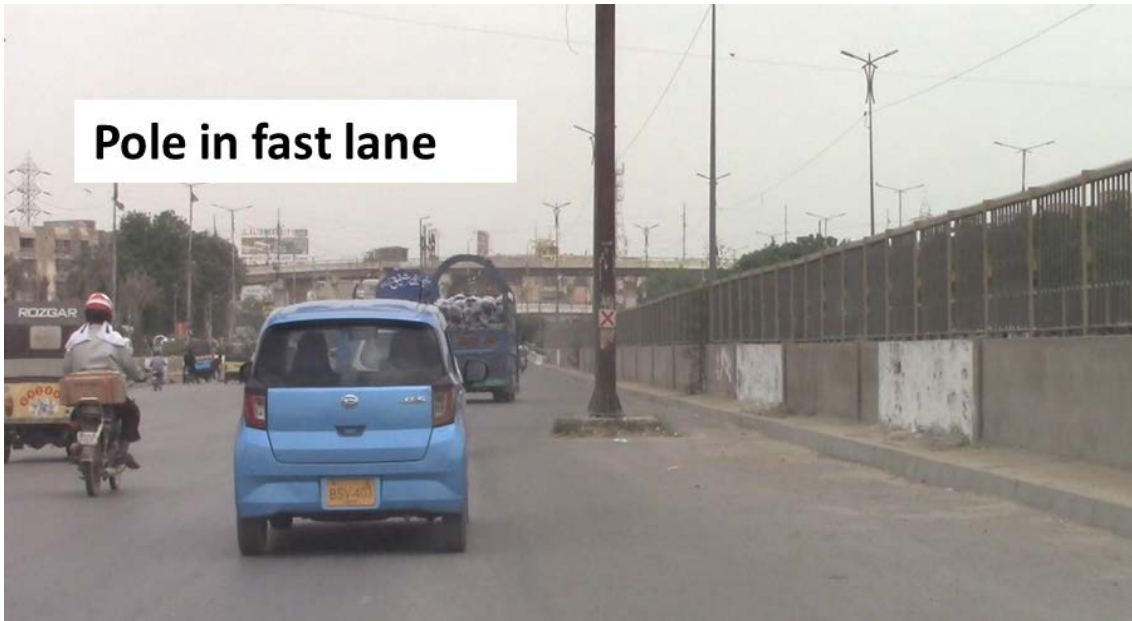
Defect Identified: Pole in fast lane

Short term: Utilization of reflectors, Proper signage of this pole at least 100 meter before.
