TOYOTA ROAD IMPROVEMENT PROJECT (TRIP)

Sher Shah Suri Road and Nawab S. A. Khan Road

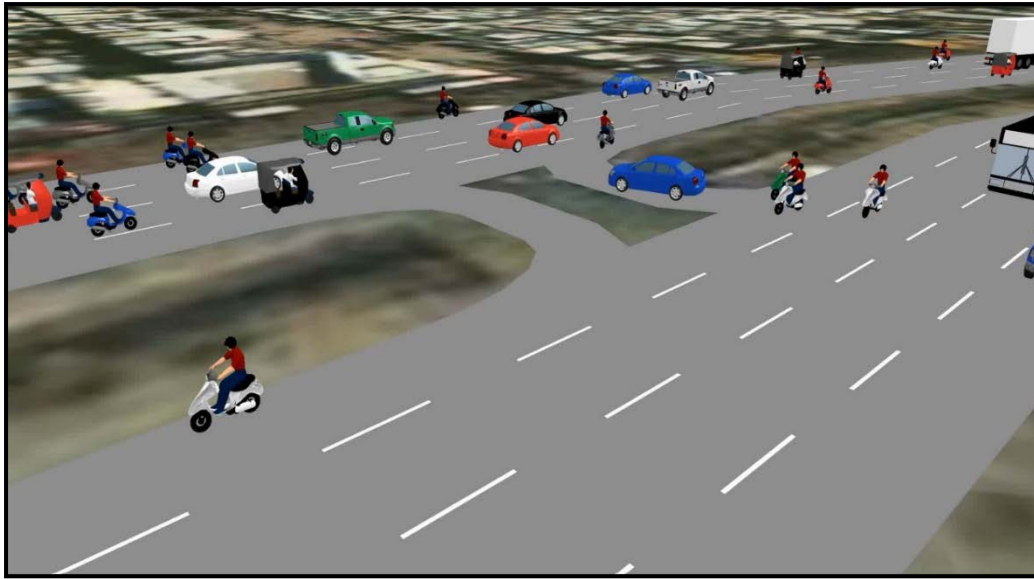
Figure 8 Sher Shah Suri and Nawab S.A.K Road 3D traffic model

Table 3 illustrates the travel time from Lasbela to Nagan Chowrangi, for a detailed analysis of travel time. Initially, the travel time under free flow conditions was calculated, and then the current travel time was determined using VISSIM software. The difference between the current travel time is 9.87 min more towards Lasbela. For the direction towards Nagan the current travel time is 10.5 mins more than the free flow travel time.
